## APPENDIX A: GLOSSARY

Appendix D - Tabulated Results - Peak Flood Discharge (m<sup>3</sup>/s)

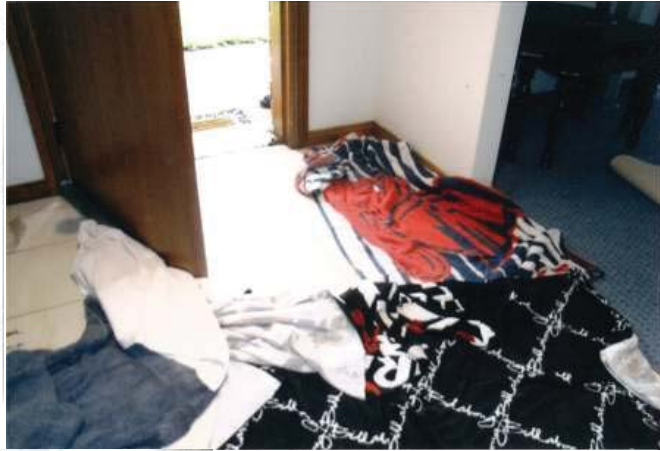
C.D. player copped.  
the rest was ok but  
couldn't use it anymore  
cause the leads had been  
soaked. & plugs sitting  
in the water.

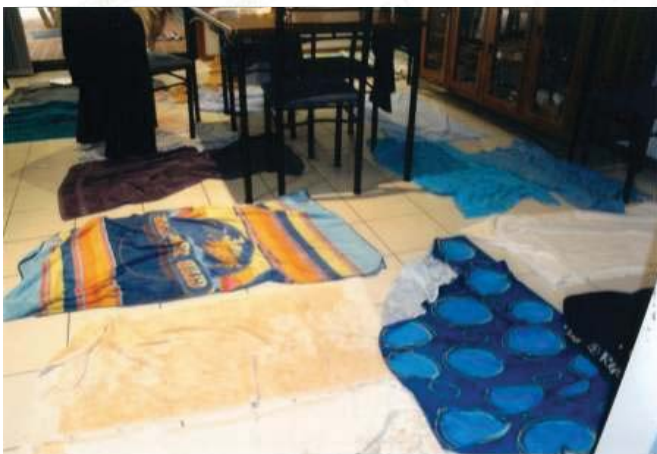
Chelsea put towels around &  
under the doors but the water  
still flowed through the house...  
I told her to open the back door & let it run  
through. she had to go to work. cause  
the pub was flooding too!  
So she left the back door open.

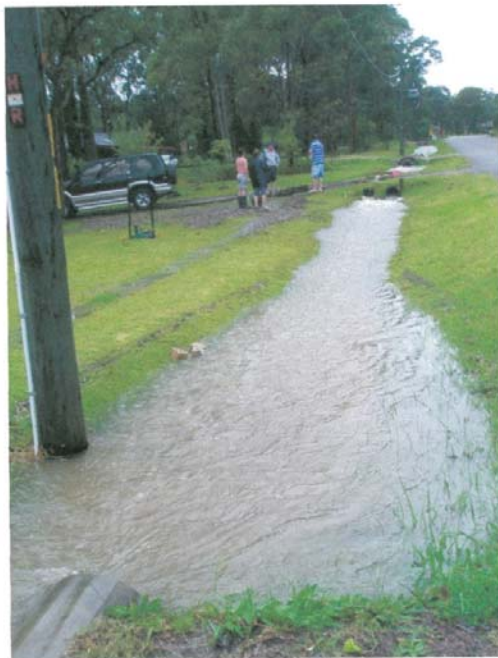
April 2008 following storm event.

15 Kula Rd next door to the drain which runs next to Karwin and under Kula

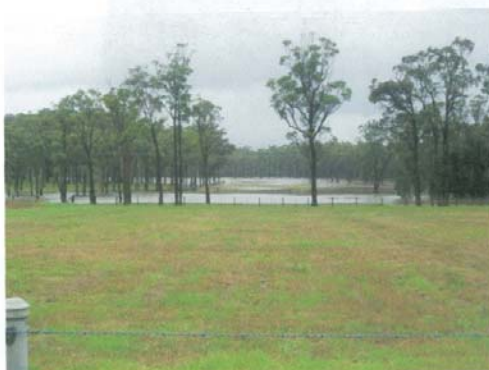
April 2008 following storm event.

Drains at front of homes in Lewis Drive, upgrade embankments and double piping has been carried out to reduce drive damage in this street. Water enters Campvale system and runs under Lewis then Ryan Rds.

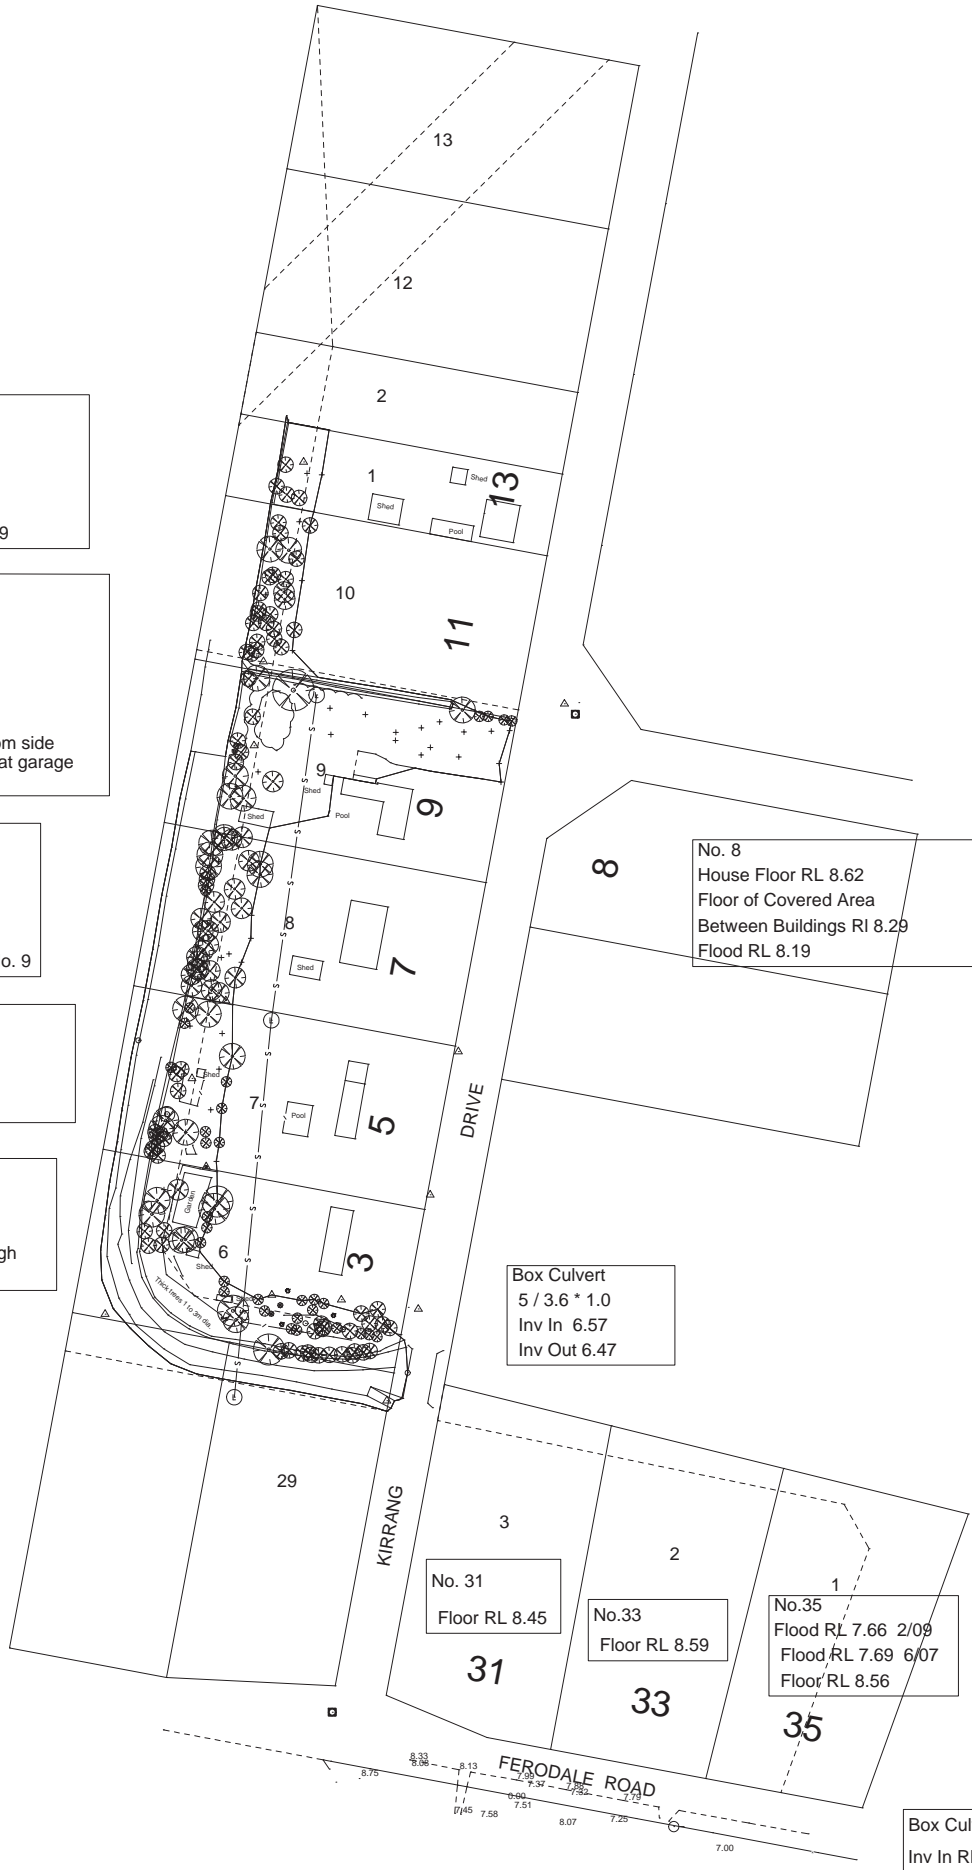
No. 13  
 House Floor RL 9.14  
 Garage Floor RL 8.90  
 Rear Shed RL 8.45  
 Flood RL 8.67  
 Pool Deck - NW Cnr RL 8.69

No. 9  
 House Floor RL 8.77  
 Garage Floor RL 8.63  
 Flood RL 8.67 - Garage  
 Flood RL 8.64 - Rear Shed  
 Floor Rear Shed RL 8.09  
 Owner says water comes from side drain - explains higher level at garage than shed

No. 7  
 House Floor RL 8.683  
 Flood RL 8.685  
 Garage Floor RL 8.41  
 Pool Surround RL 8.50  
 Water comes from front of No. 9

No. 5  
 House Floor RL 8.876  
 Flood RL 8.666  
 Pool Surround RL 8.50

No. 3  
 House Floor RL 8.59  
 Garage Floor RL 8.586  
 Flood Level RL 8.588  
 Water entered house through door to garage.

No. 8  
 House Floor RL 8.62  
 Floor of Covered Area Between Buildings RI 8.29  
 Flood RL 8.19

Box Culvert  
 5 / 3.6 \* 1.0  
 Inv In 6.57  
 Inv Out 6.47

No. 35  
 Flood RL 7.66 2/09  
 Flood RL 7.69 6/07  
 Floor RL 8.56

Box Culvert  
 Inv In RL 6.20  
 Inv Out RL 6.11
