RAAF Base Williamtown / Newcastle Airport Employment Zone Land Use Development Strategy

Stage 2: Revised Preliminary Geotechnical Assessment

August 2007

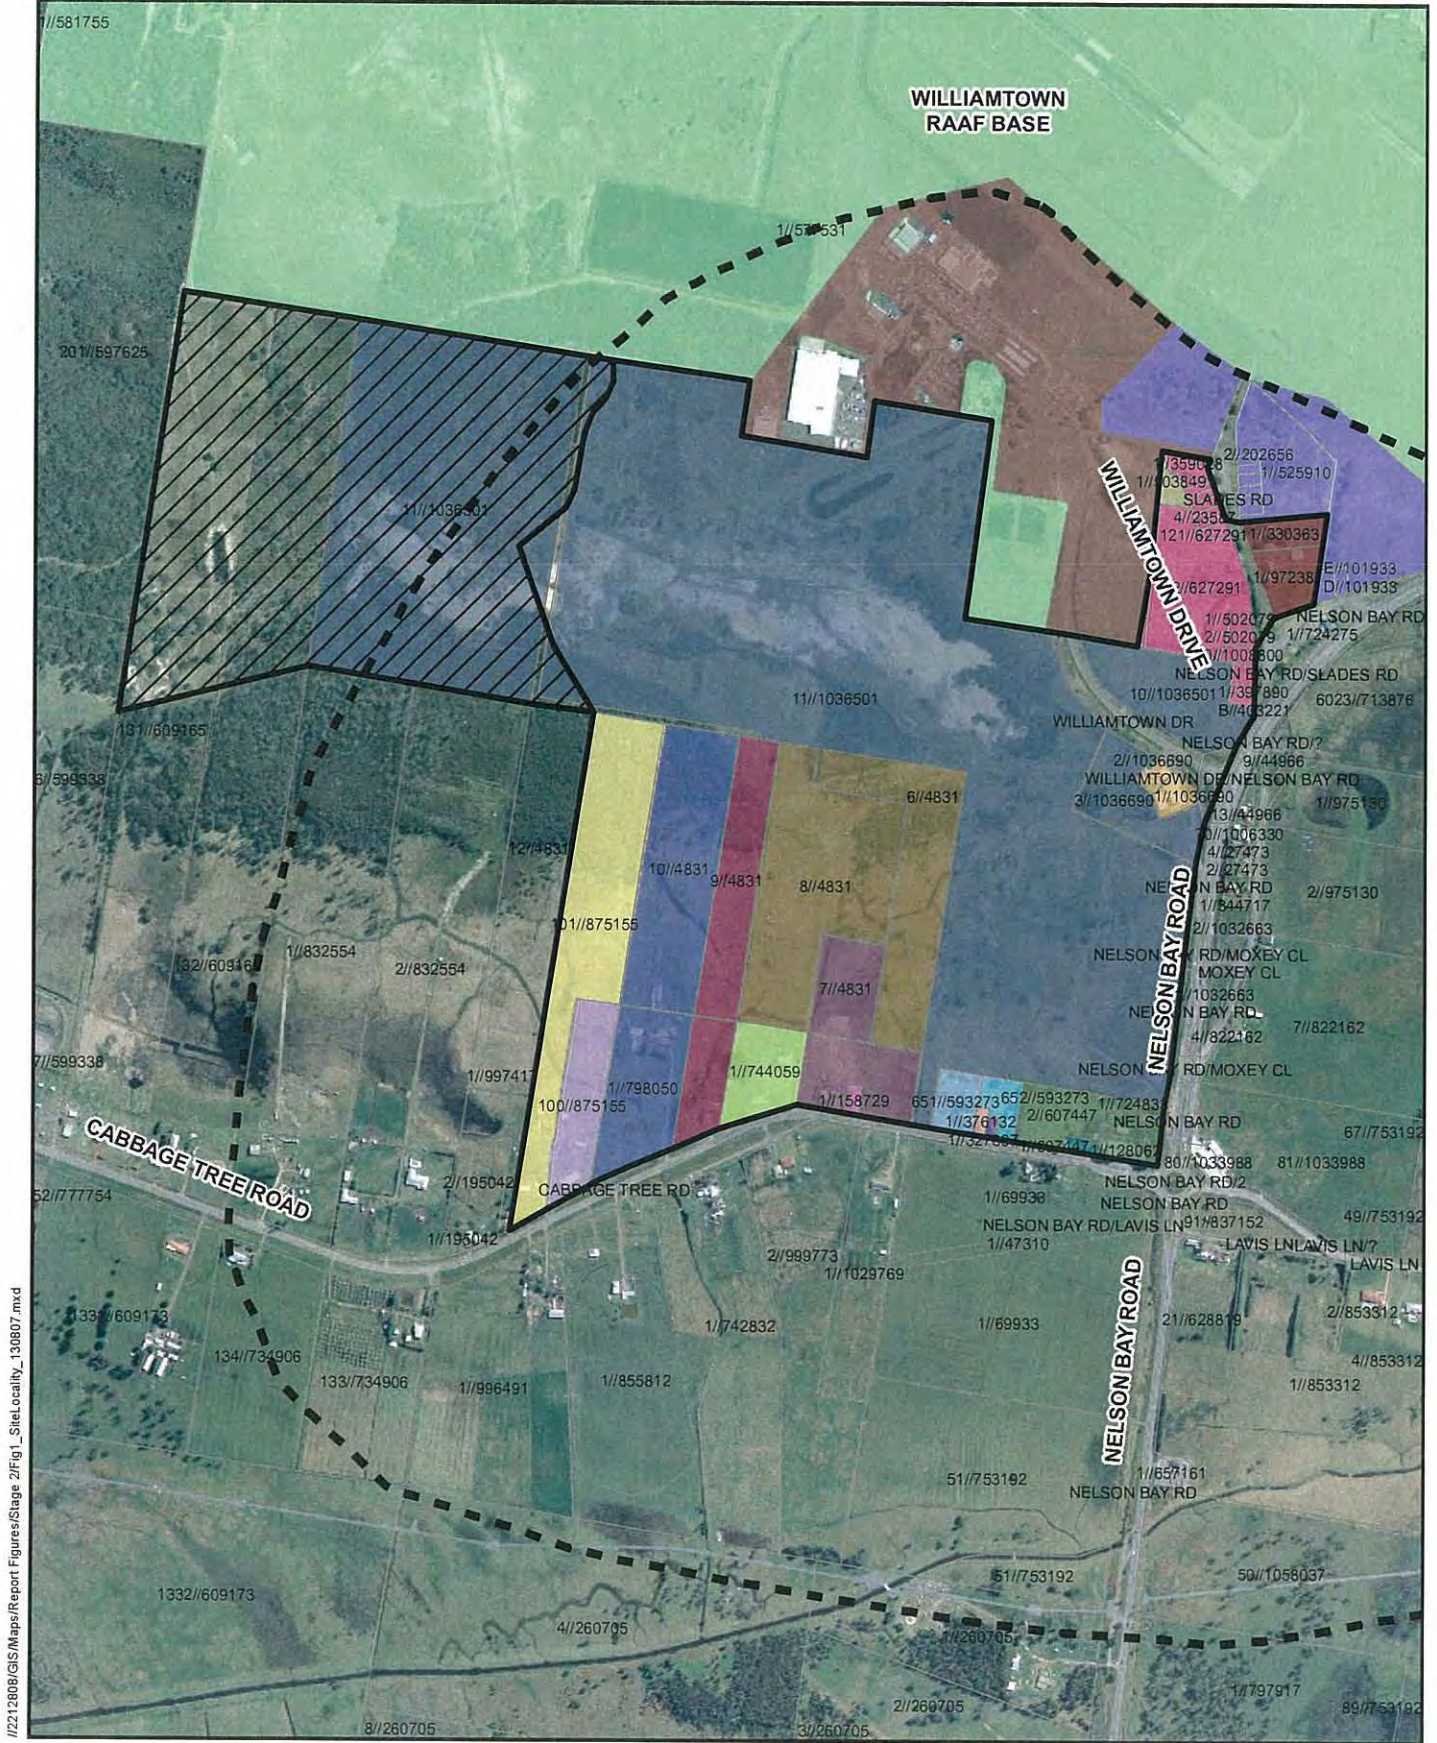
- Investigation Area (Stage 2)
- Additional Land for Investigation
- Study Area (Original Stage 1)

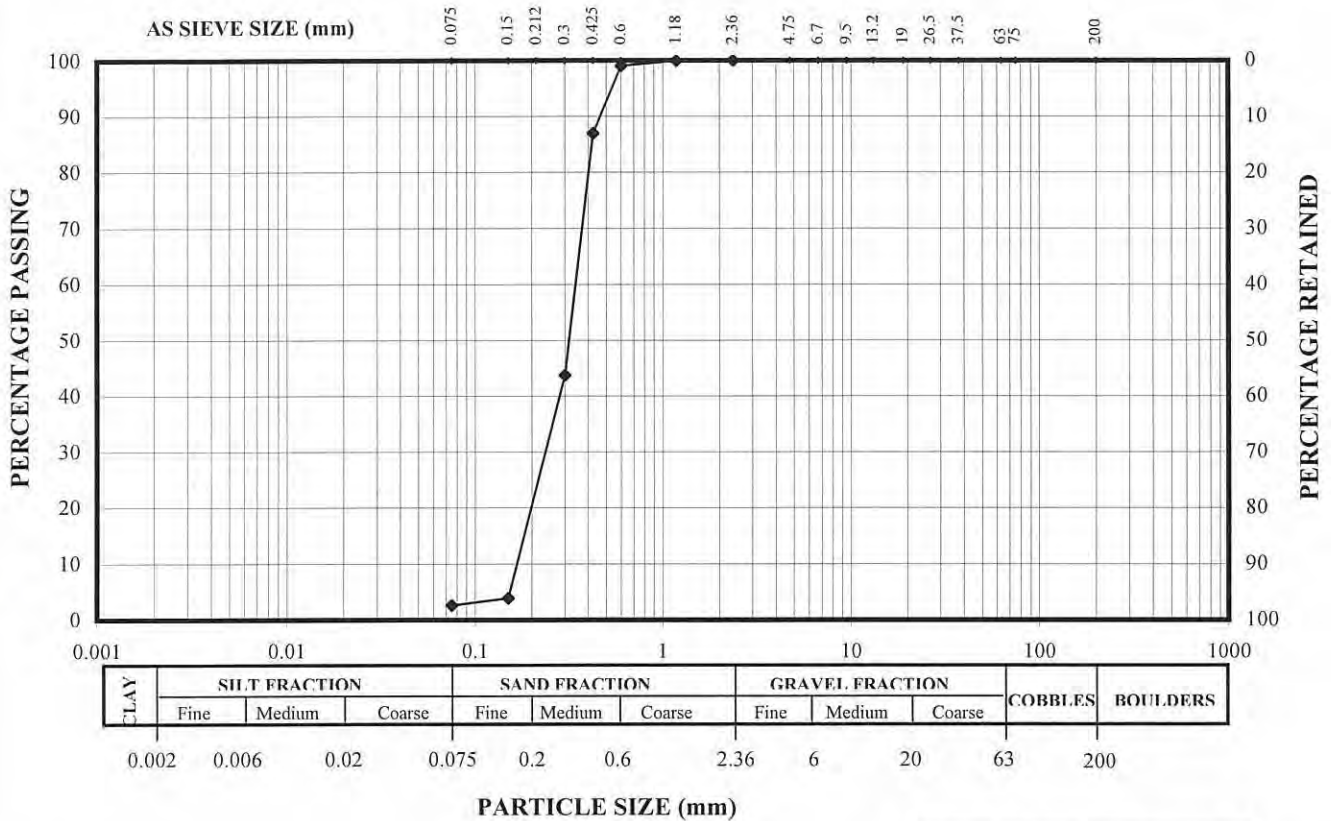
SOIL NAME: Poorly graded SAND
