Living on the Edge

The Port Stephens Foreshore Reference Document Attachment 1 to Port Stephens Foreshore Management Plan

AUGUST 2009

Port Stephens Foreshore Plan of Management – Ecology Reference Document

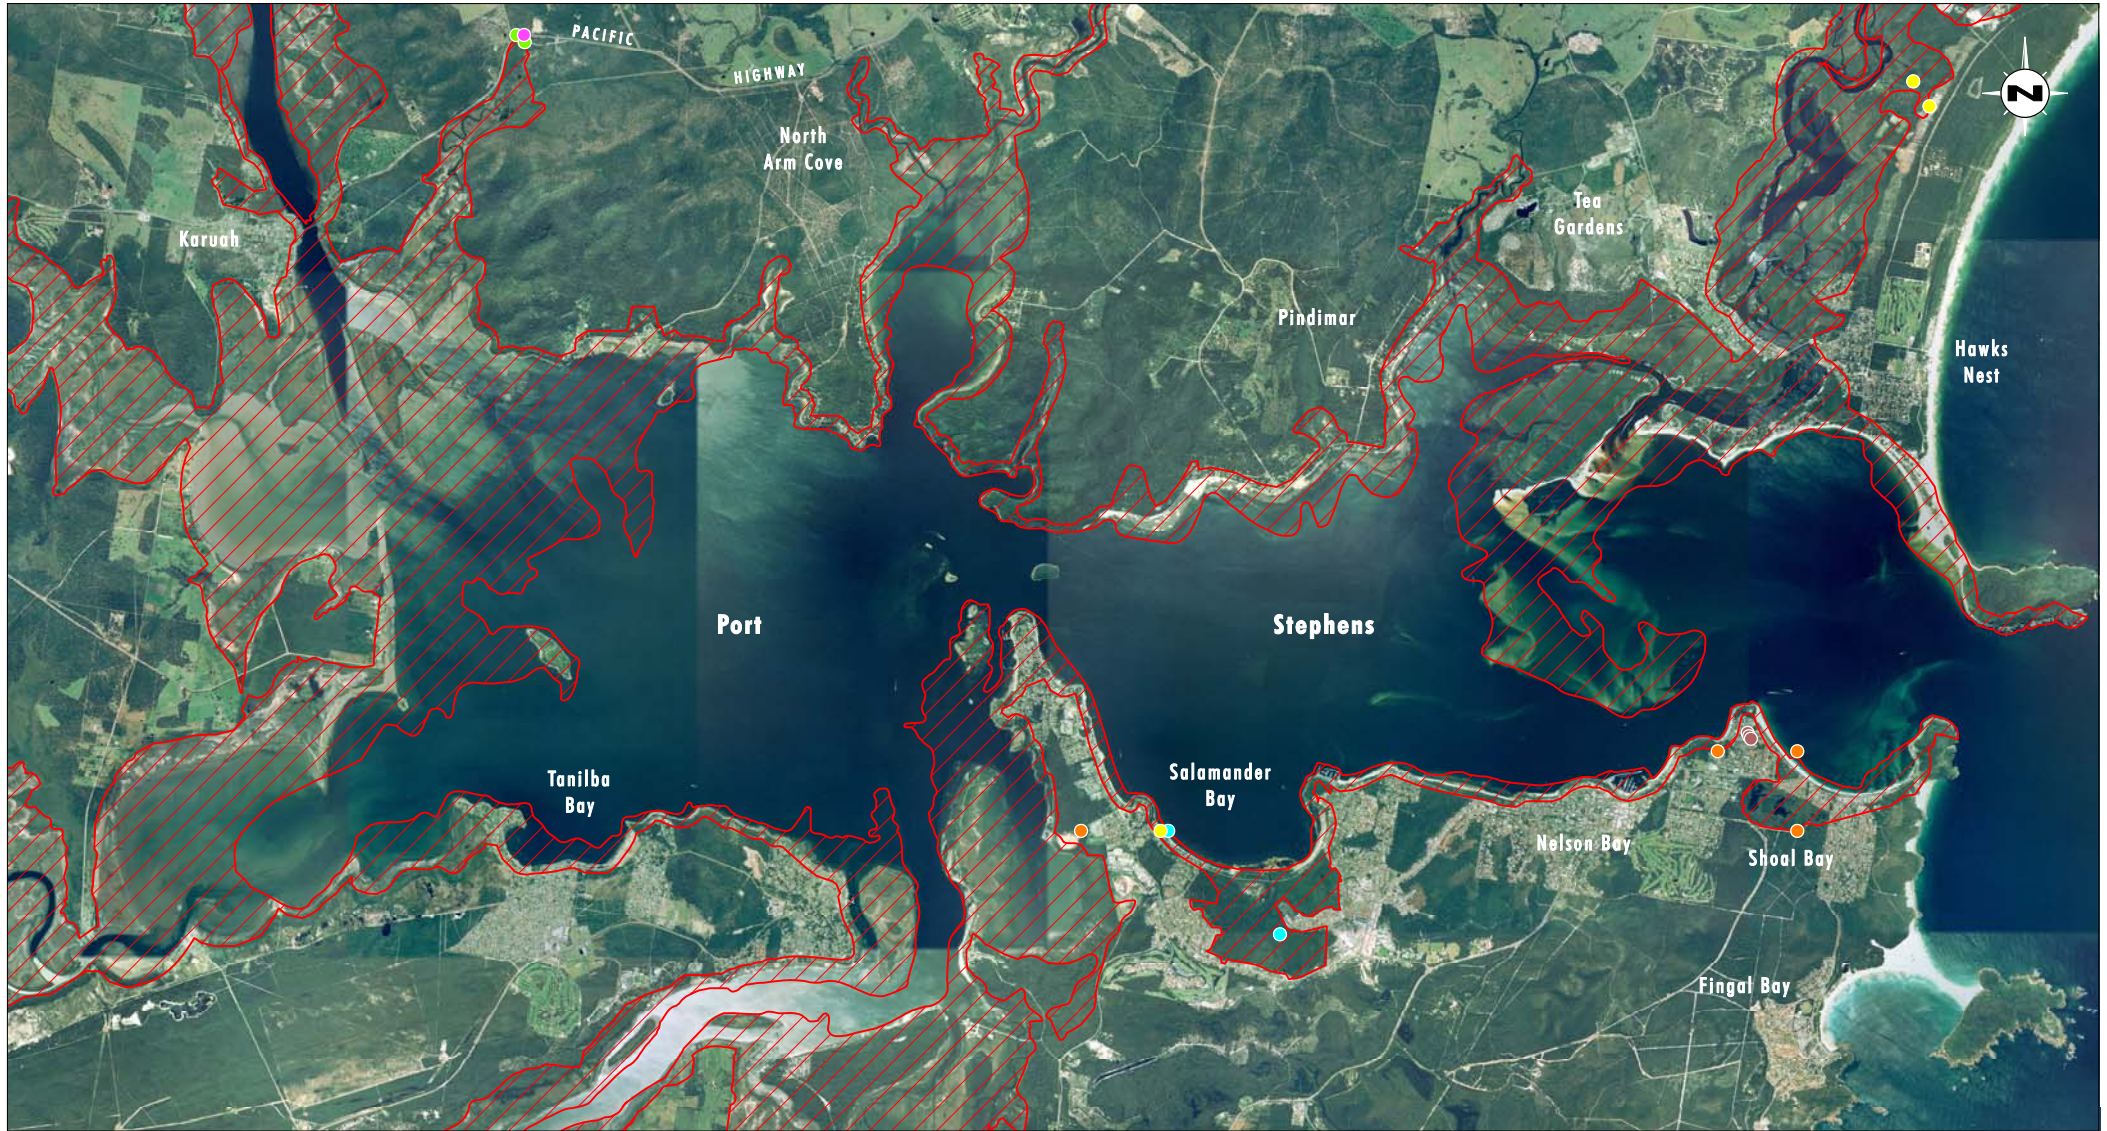
FIGURE 5.4

Threatened Flora Species Records

One threatened flora species, sand double-tail (*Diuris arenaria*), has been recorded just outside the foreshore boundary within this management zone (**Figure 5.4**). Threatened fauna species recorded include koala (*Phascolarctos cinereus*), bush-stone curlew (*Burhinus grallarius*), grey-headed flying fox (*Pteropus poliocephalus*), green turtle (*Chelonia mydas*), squirrel glider (*Petaurus norfolcensis*), pied oystercatcher (*Haematopus longirostris*) and brush-tailed phascogale (*Phascogale tapoatafa*) (**Figure 5.5**). An area of 85 hectares of preferred koala habitat has been identified around the foreshore of Cromartys Bay on the Salamander Bay side. A small (8 hectare) area of supplementary koala habitat occurs around Cromartys Bay (**Figure 5.6**).

A search of the Department of Environment and Conservation (DEC) Atlas of NSW Wildlife was undertaken in order to identify threatened flora species that have previously been recorded within the Port Stephens Foreshore area. **Table 9.1** lists the five threatened flora species that were found to occur within the study area, the locations of which are shown on **Figure 5.4**.

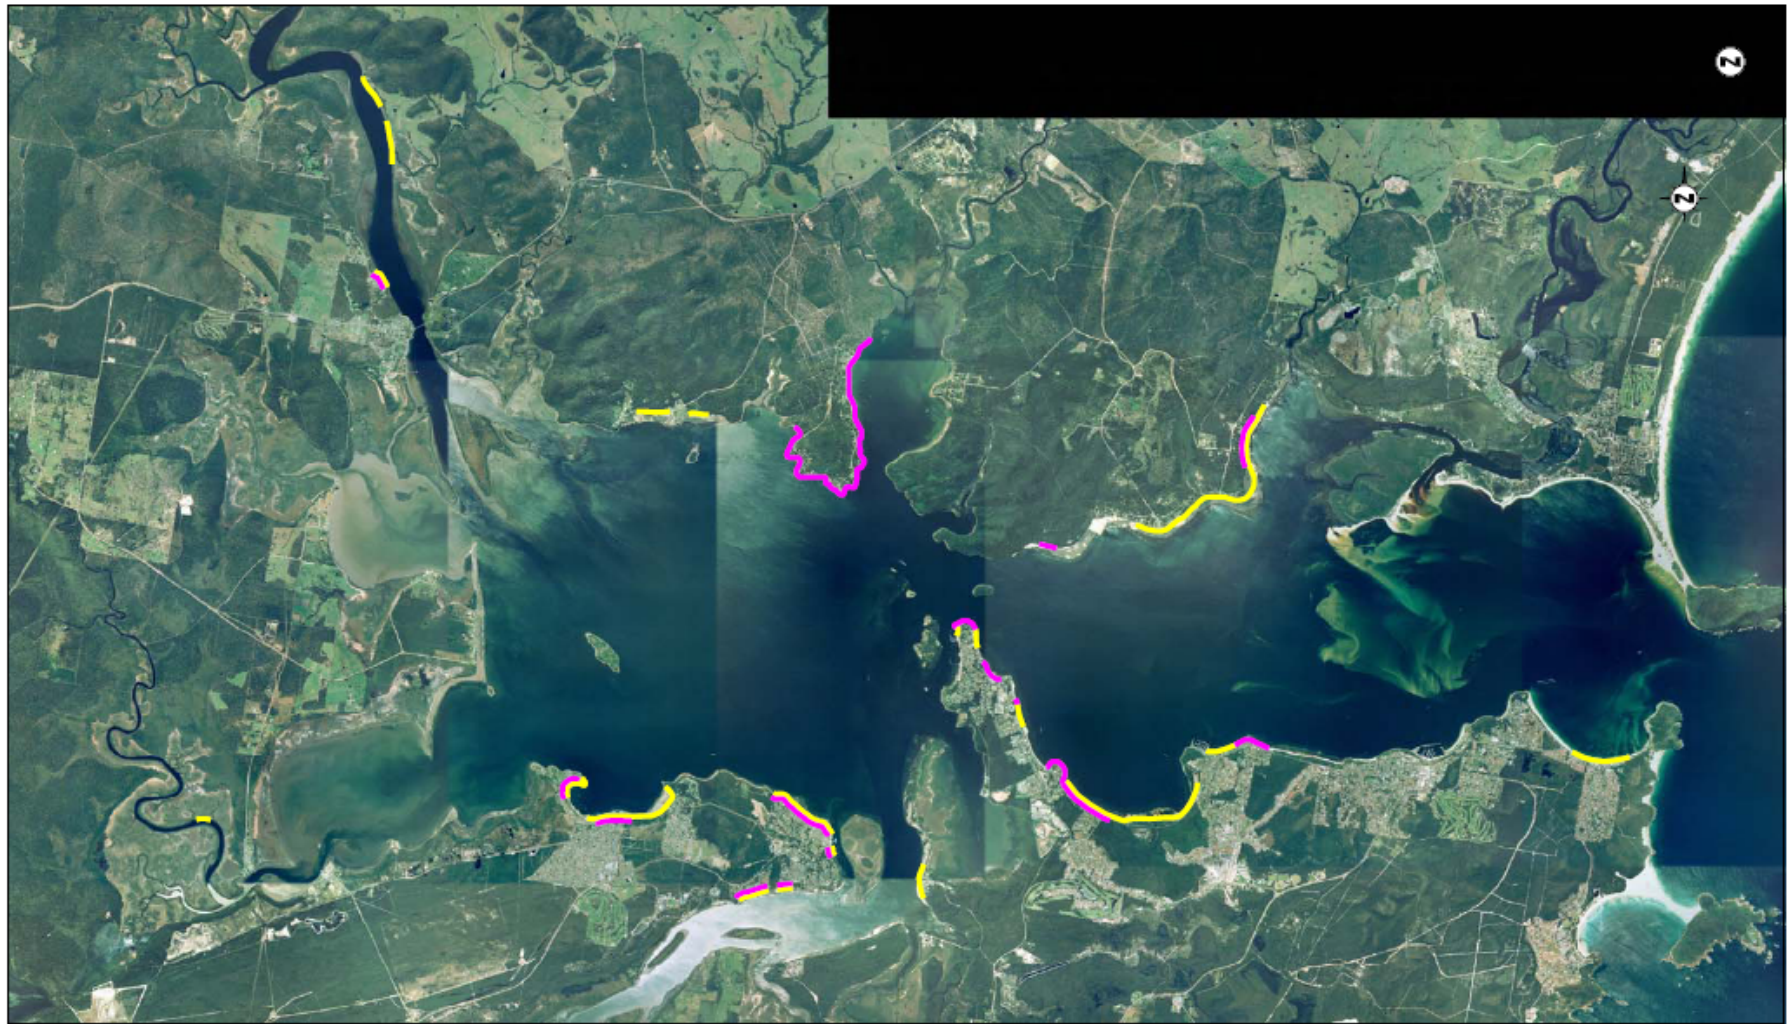
Figure 1.1. Locations of perceived significant foreshore erosion and structures
(source: Umwelt)

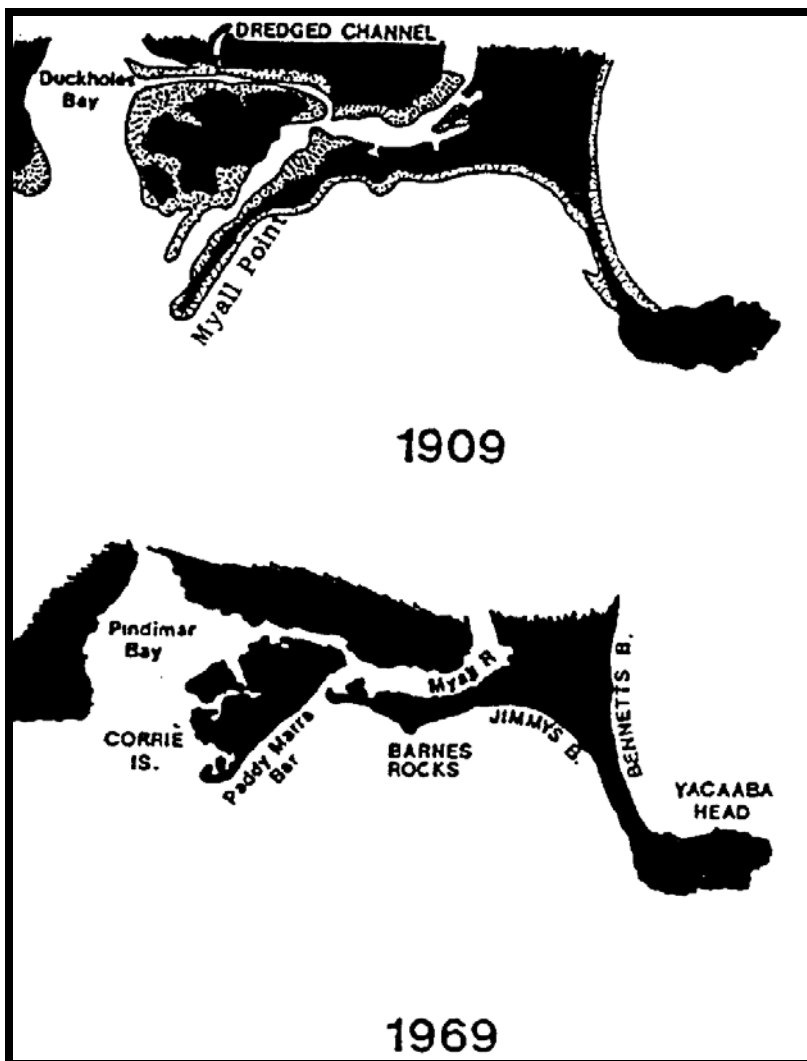
(1) Changes to the northern foreshore of the Outer Port 1909 – 1969

Figure 2.1. Foreshore changes and coastal processes in the Outer Port (after Nielsen, 1994)

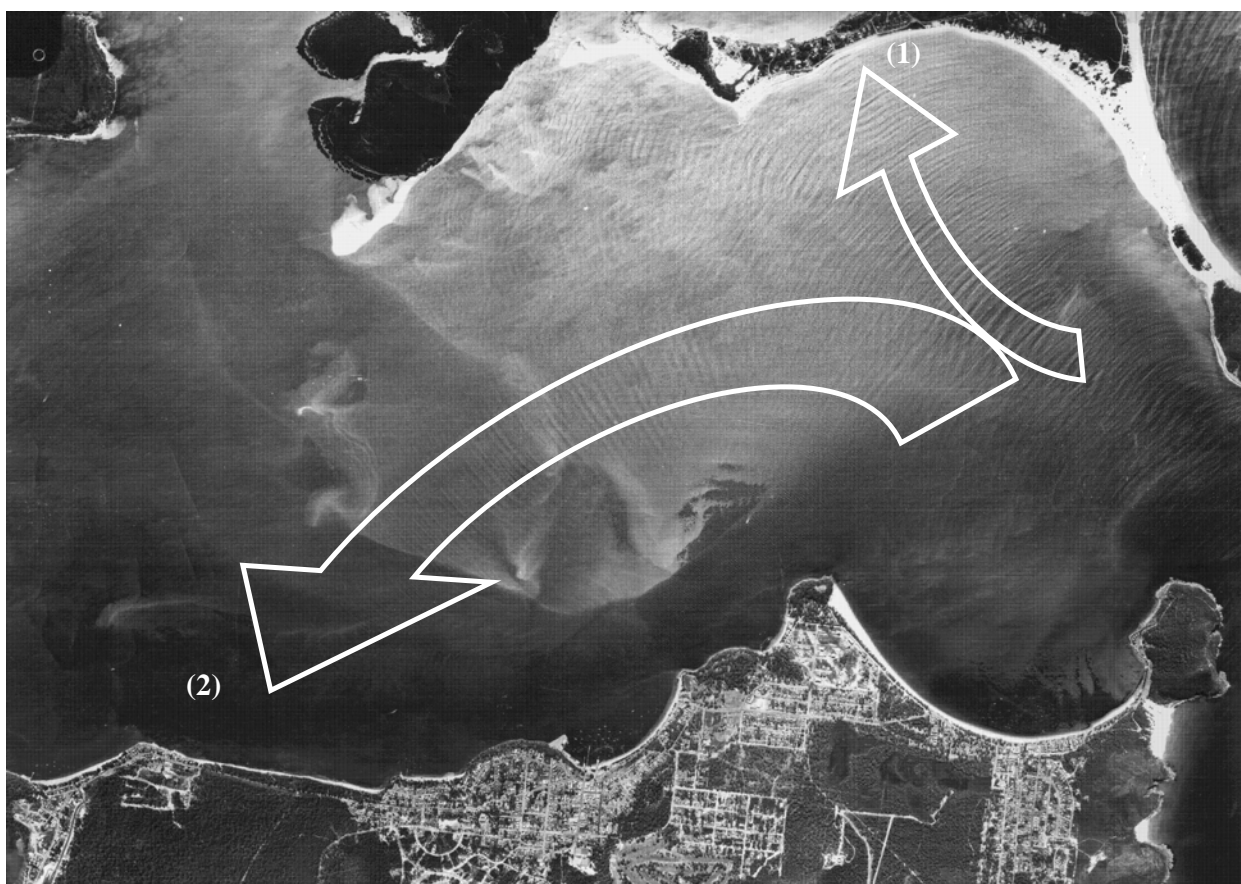
**Figure 2.2. Swell Wave Refraction within the Outer Port.
1976 Census Aerial Photograph (taken 27/5/1975) showing impacts of
wave refraction on swell wave transformation into Port Stephens.
Arrows show general directions of swell wave focussing onto:
(1) Jimmys Beach; and
(2) Sandy Point.**

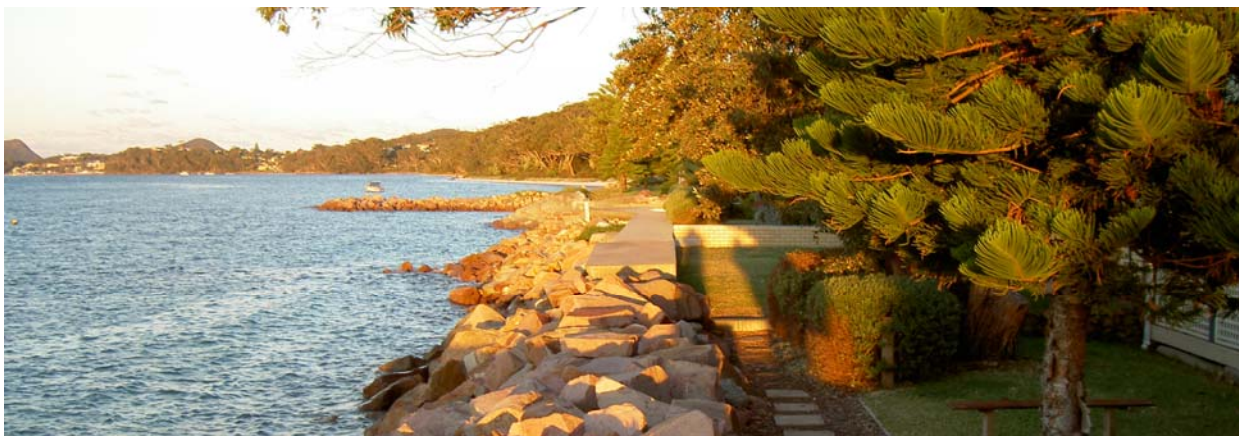
(1) Revetments and groynes protecting development on the north-eastern side of Sandy Point

Figure 2.3. Sandy Point (top & centre) and Corlette Beach

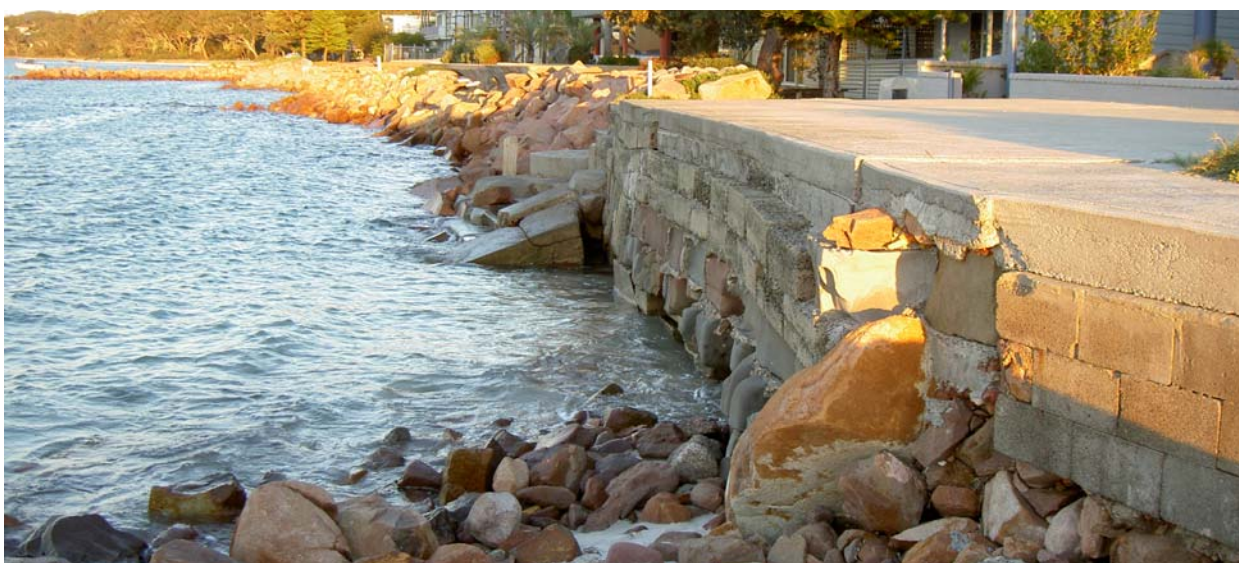
(2) Dangerous and unsound seawalls at Sandy Point

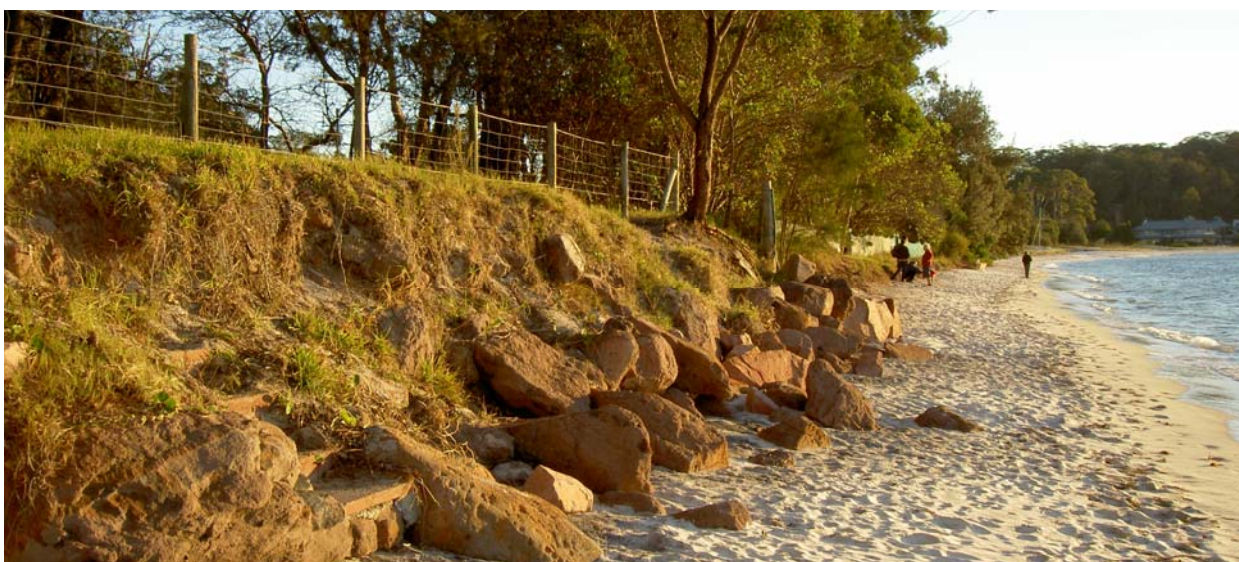
(3) Erosion of the dune and haphazard rock “protection” at the eastern end of Corlette Beach

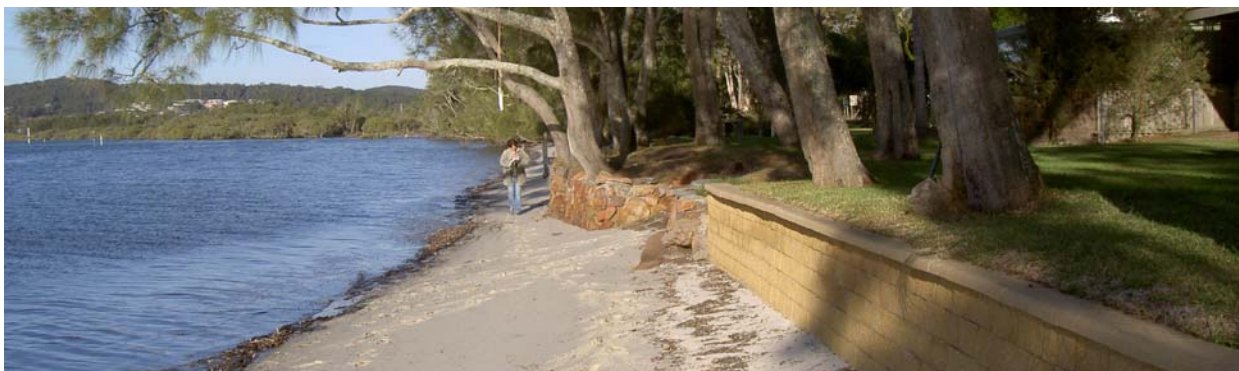
(1) Protection of foreshore reclamation at western end of Salamander Bay

Figure 2.4. Salamander Bay.

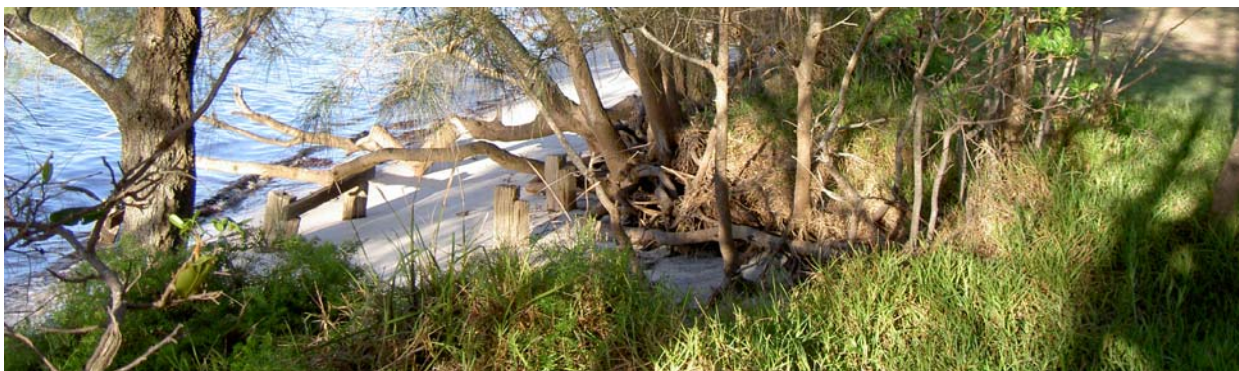
(2) Foreshore erosion of the “natural” parkland east of (1) above

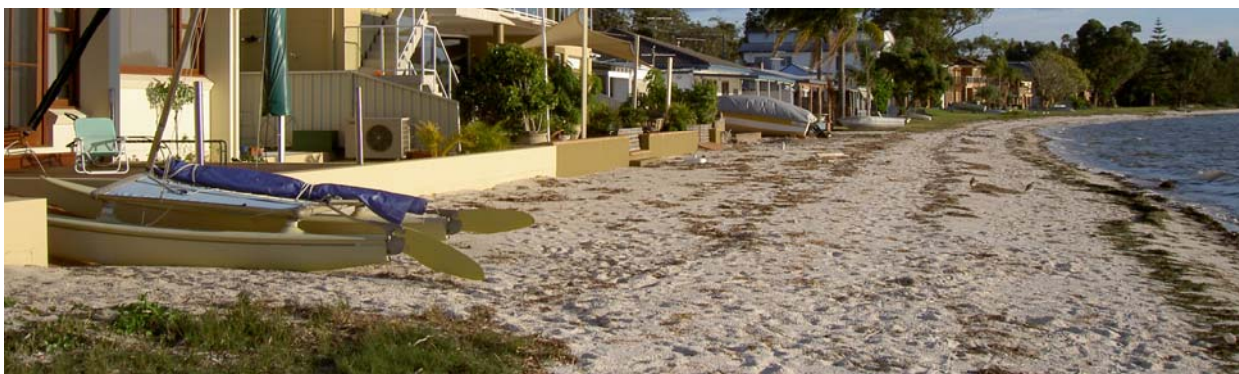
(3) Residential development at risk of wave inundation at the eastern end of Salamander Bay

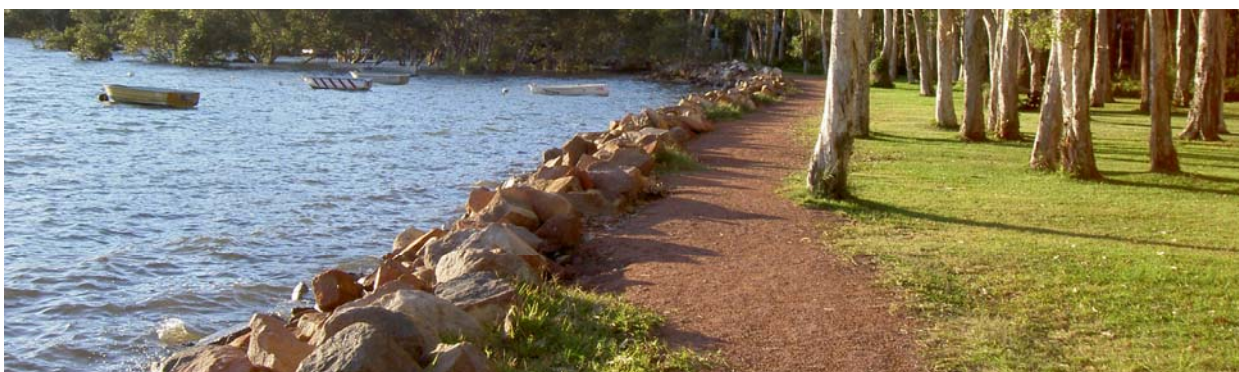
(4) Protection of parkland reclamation north-eastern end of Salamander Bay

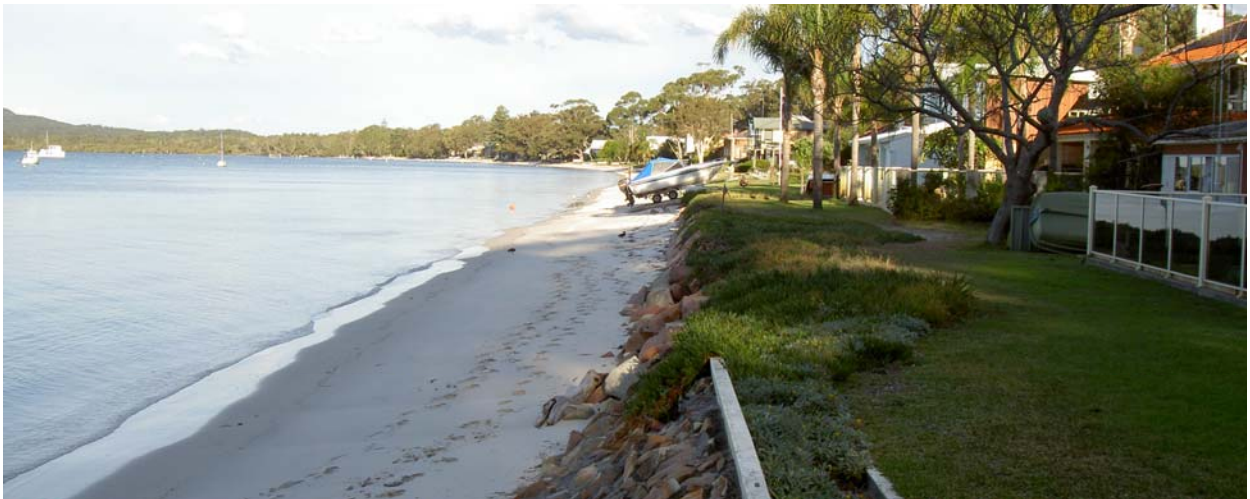
(2) Northern residences with rock protection works

Figure 2.5 Bob Cairns Reserve

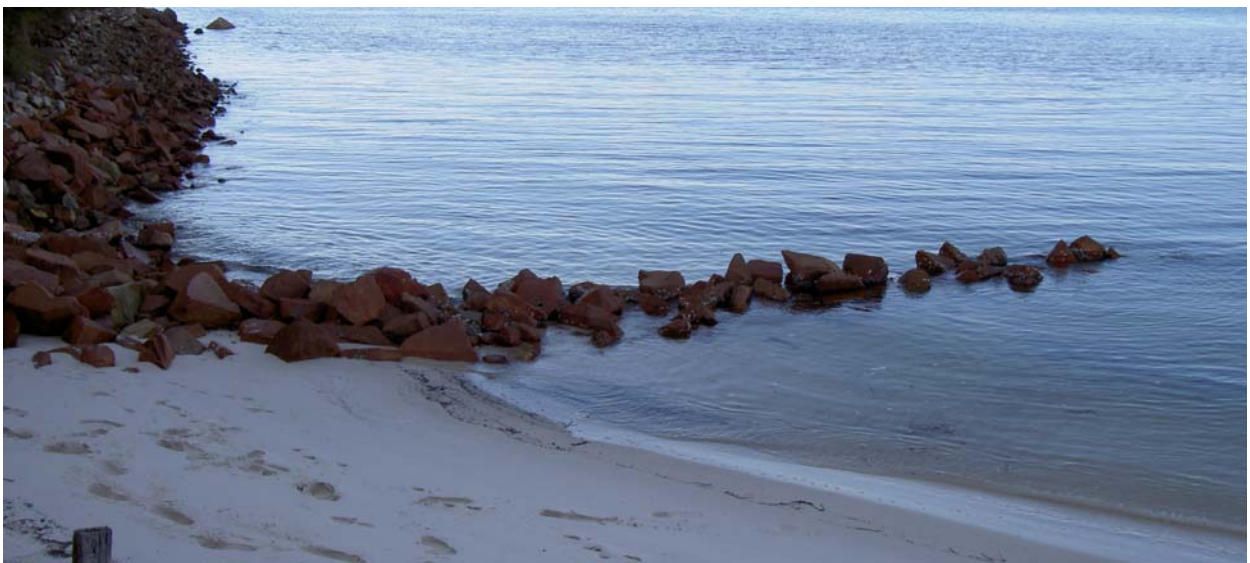
(3) Rock groyne at the northern end of the beach

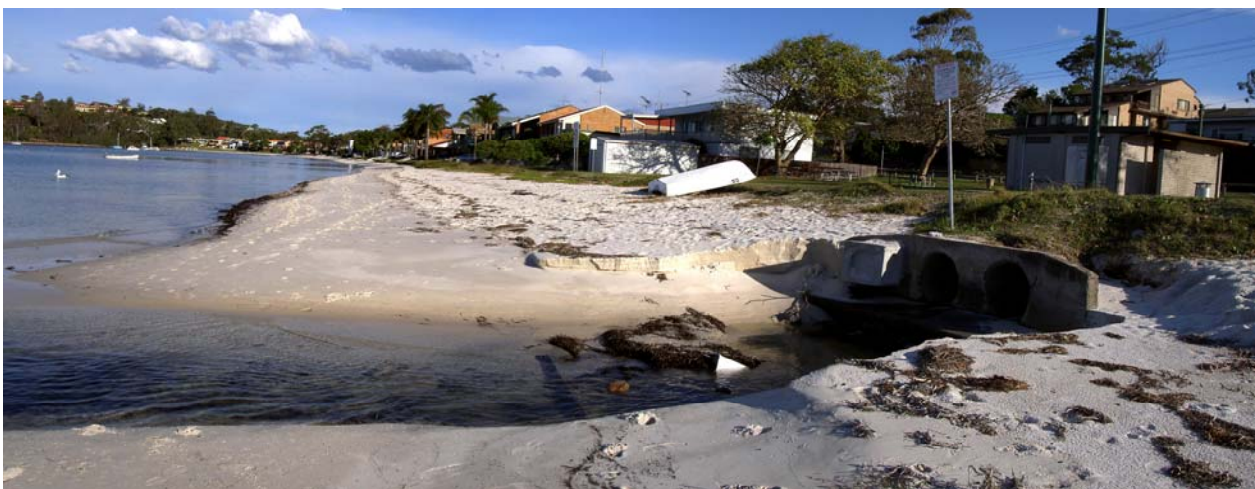
(2) Stormwater outlet on the beach.

Figure 2.6 Wanda Beach

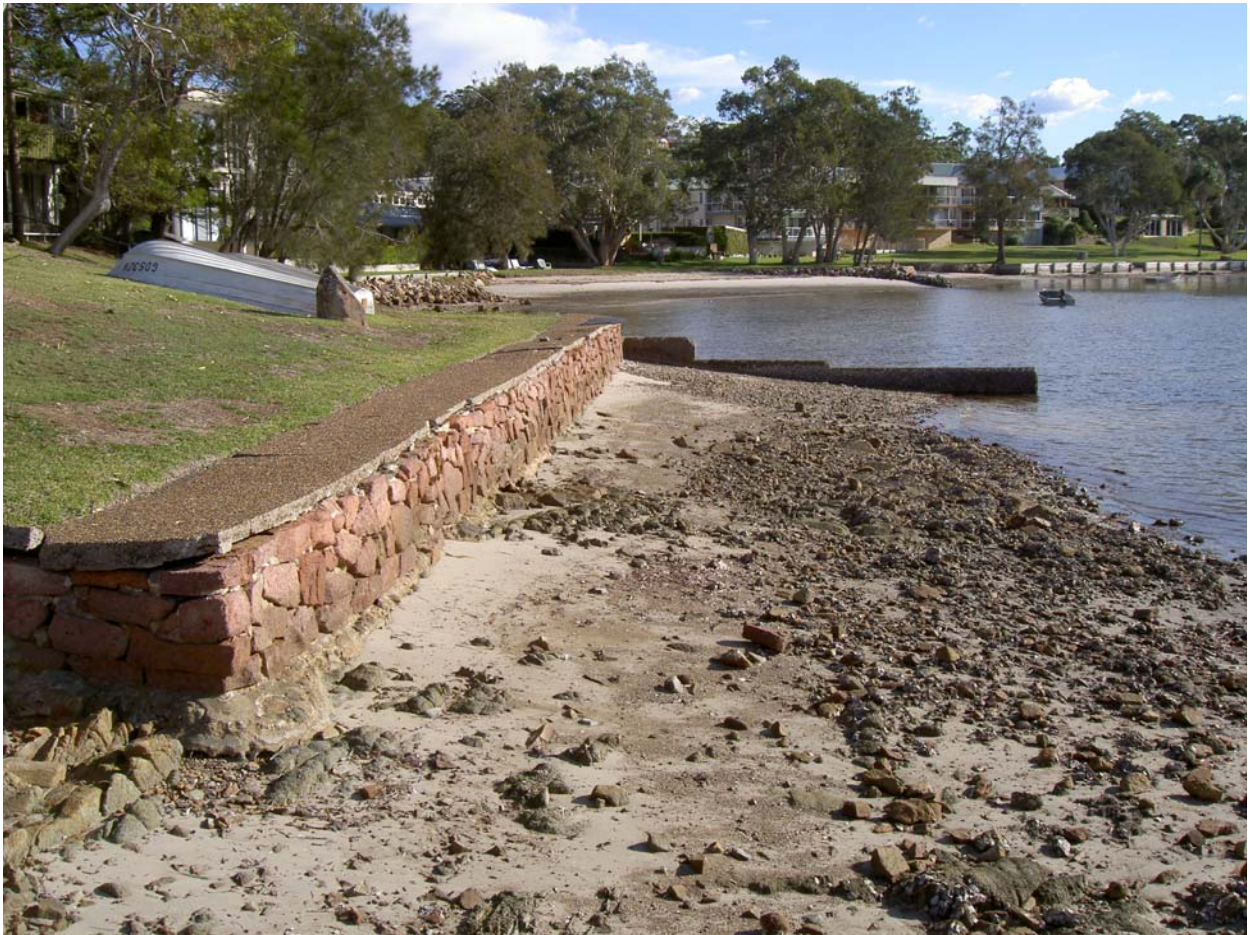
(1) A range of seawalls and groynes along this foreshore

Figure 2.7 Kangaroo Point

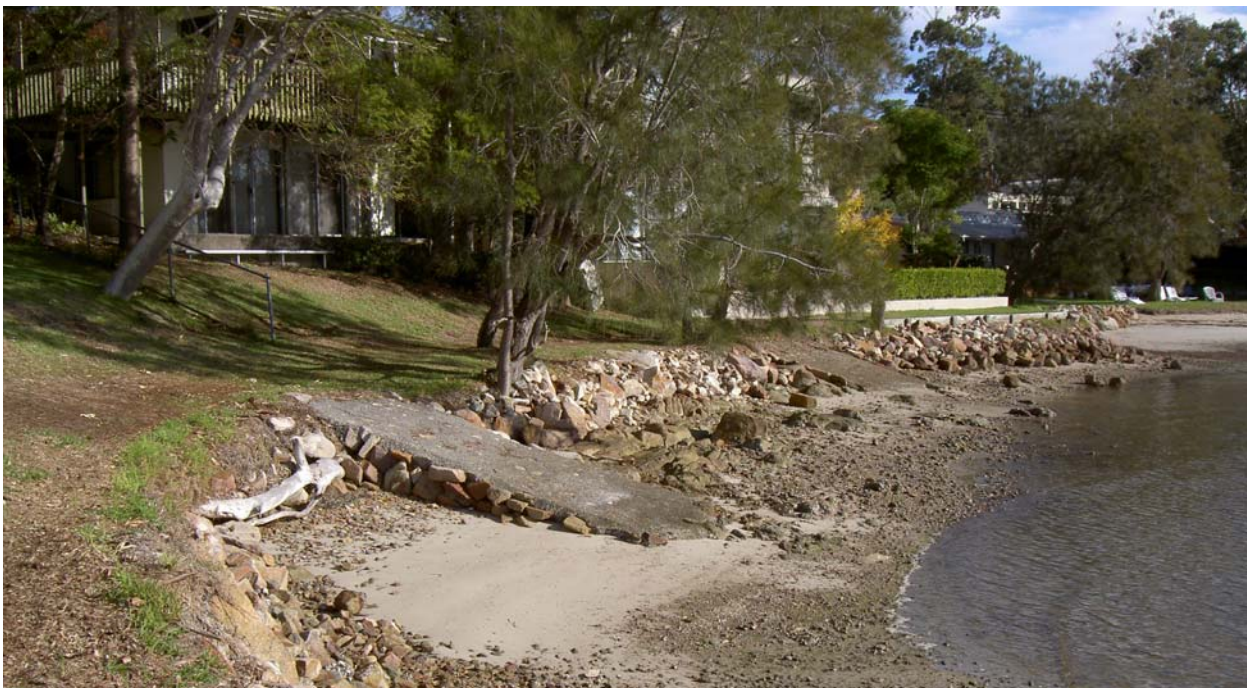
(2) Boat-ramps crossing the foreshore

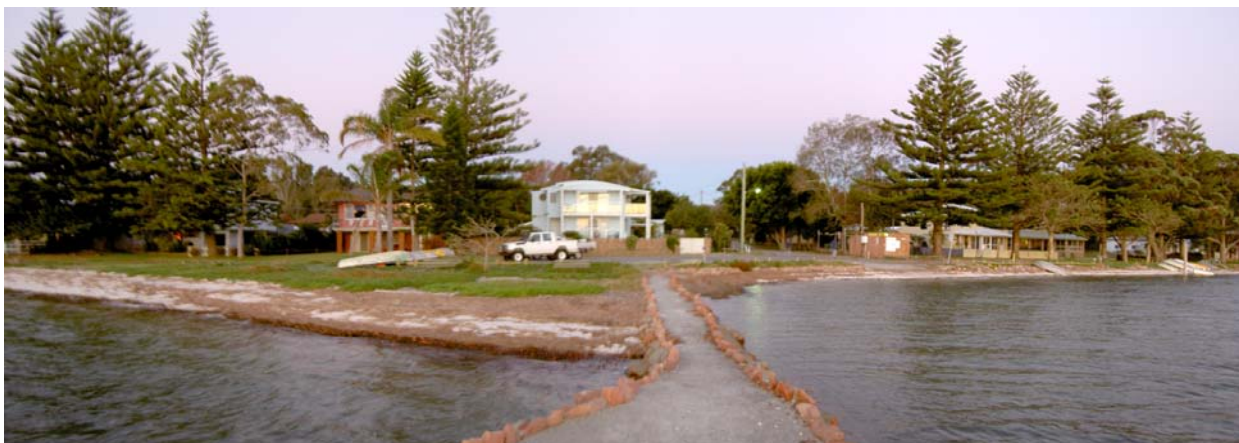
(1) Groyne effect on littoral drift transport.

Figure 2.8. Taylors Beach

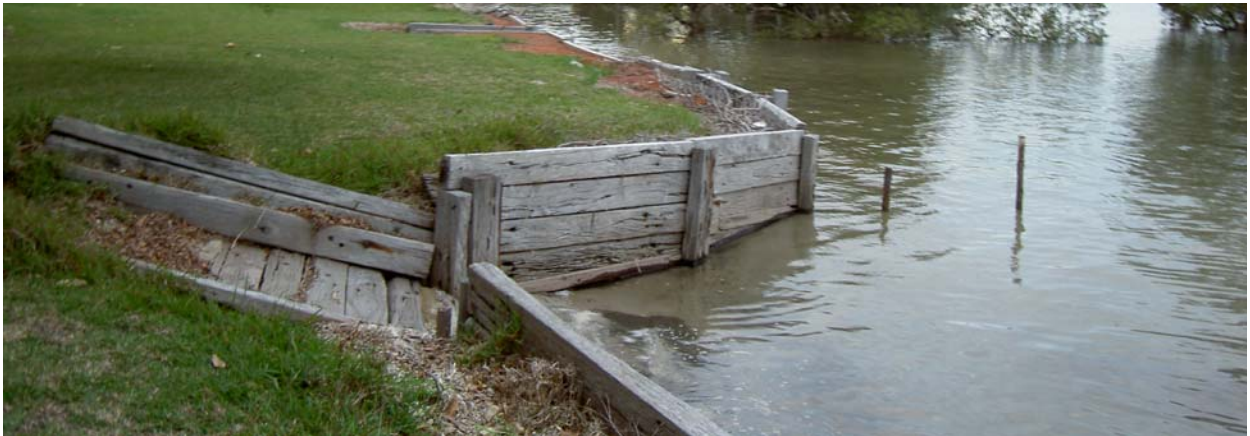
(1) Timber revetment and boat-launching ramp.

Figure 2.9. Lower Tilligerry Creek

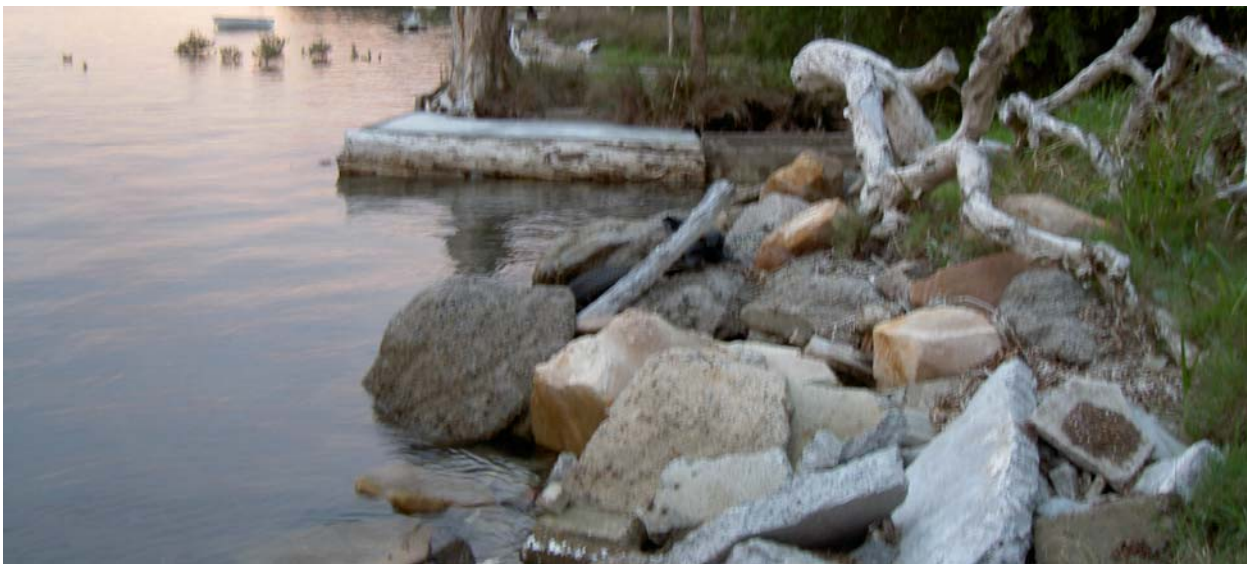
(2) Concrete rubble revetment.

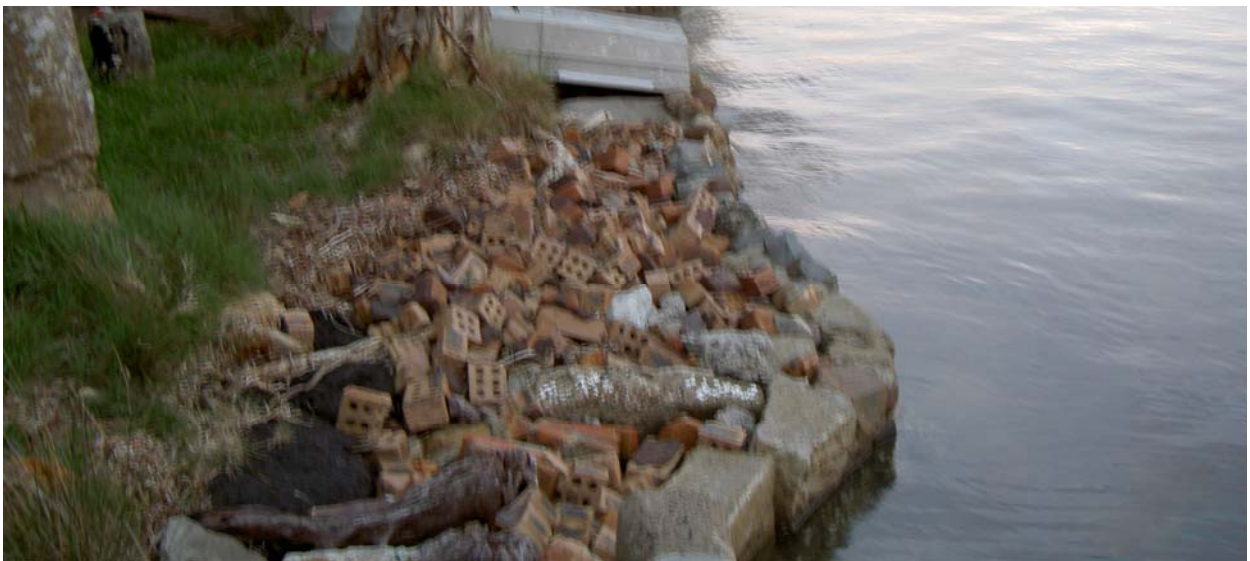
(3) Concrete and brick-bat revetment.

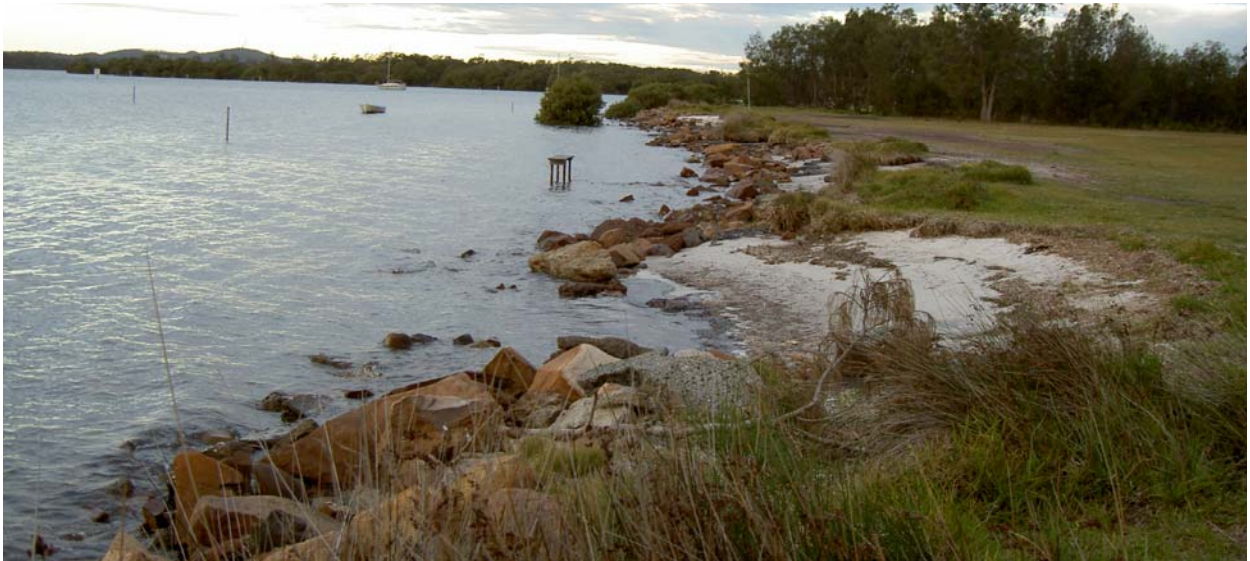
(1) Dumped rock rubble at foreshore reserve.

Figure 2.10. Lemon Tree Passage

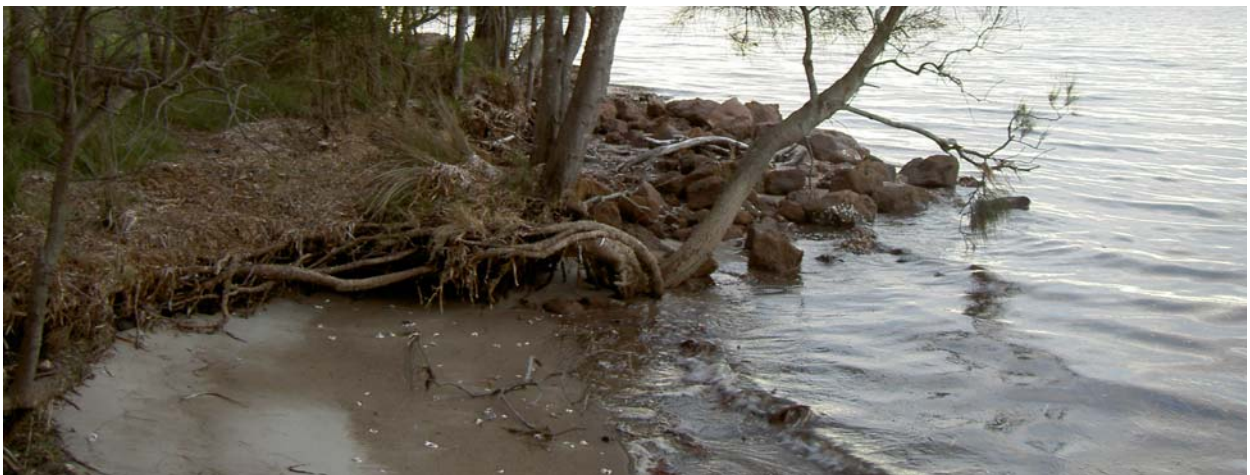
(2) Foreshore erosion around trees and dumped rock rubble.

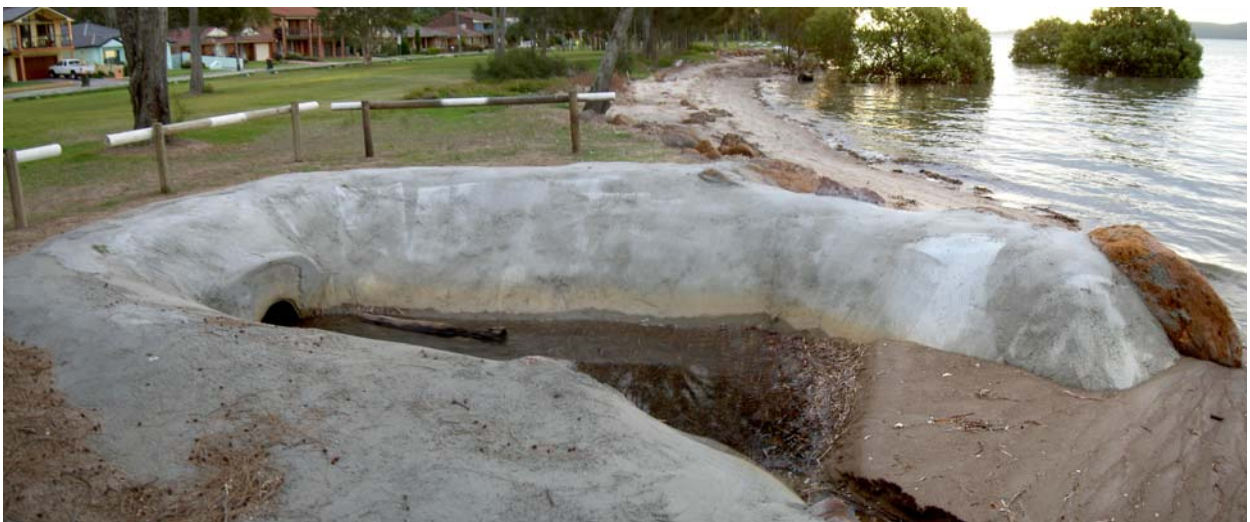
(3) Stormwater outlet.

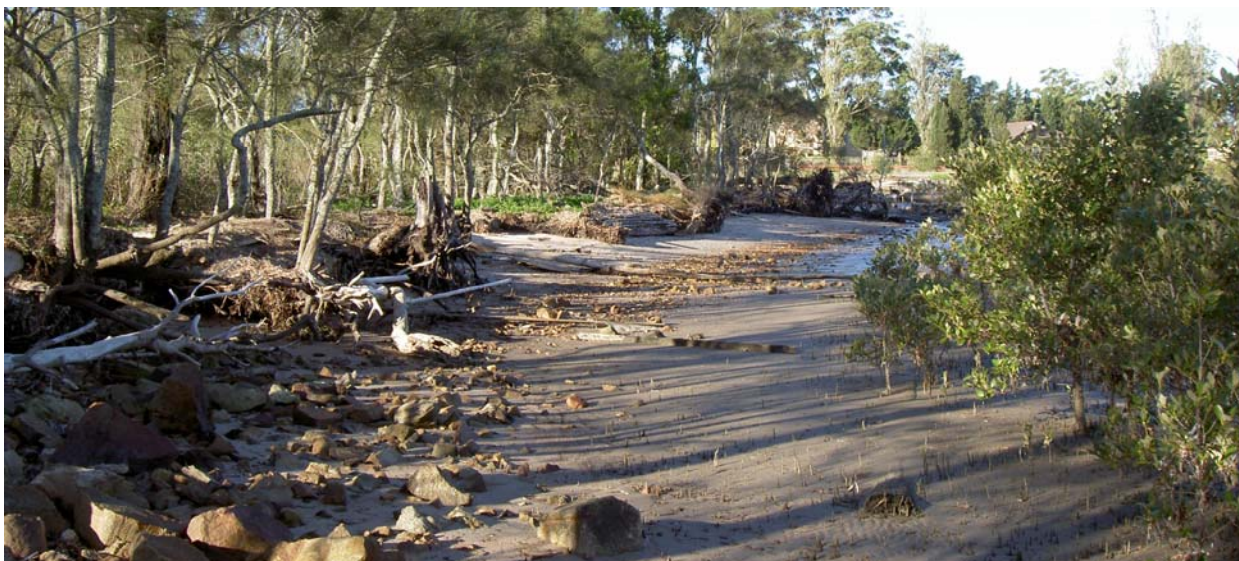
(1) Foreshore erosion around trees beyond dumped rock rubble.

Figure 2.11. Carrington

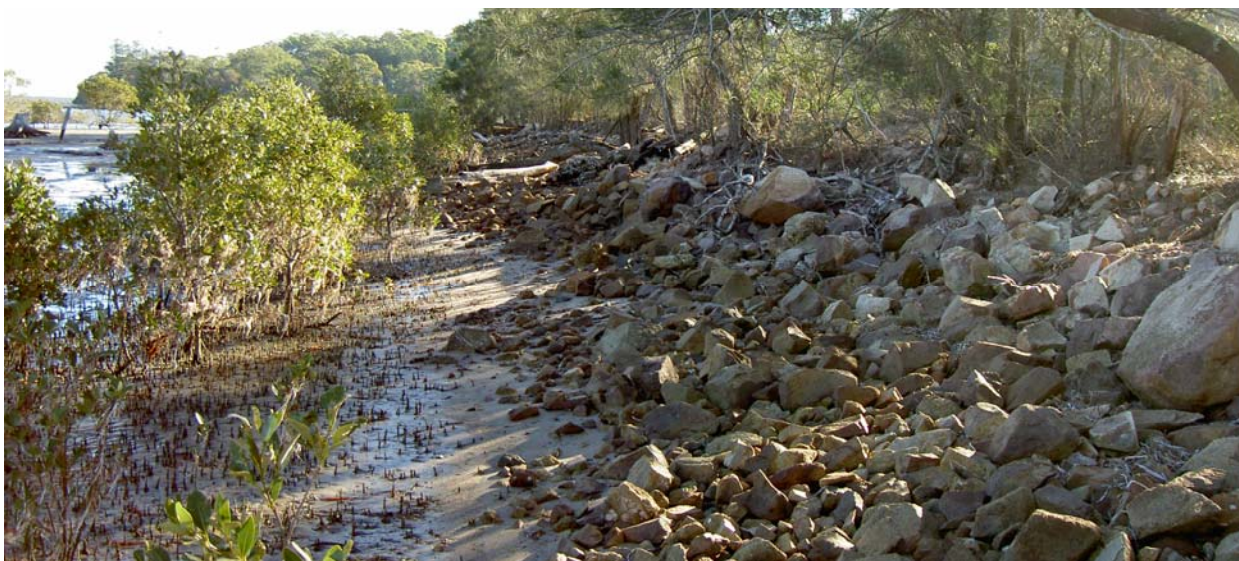
(2) Dumped rock rubble.

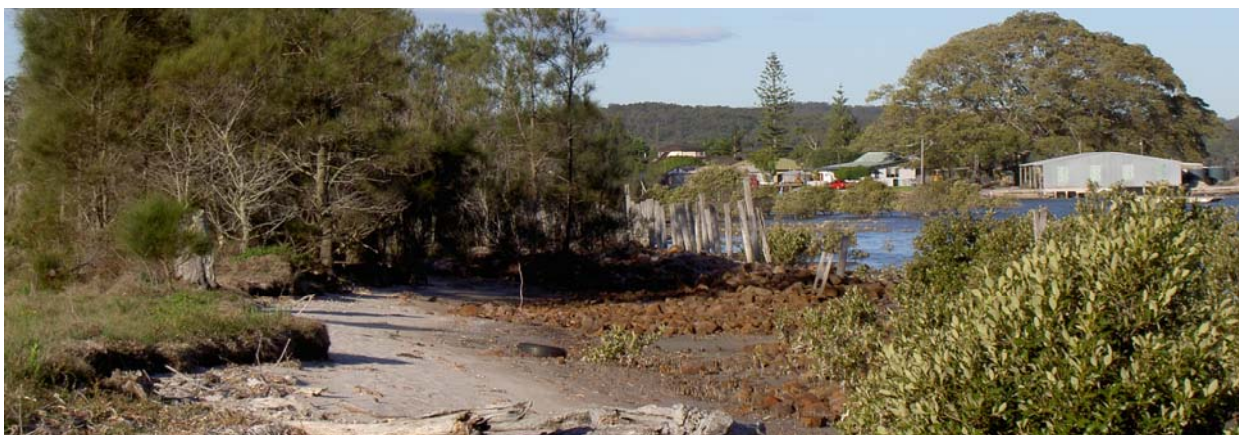
(3) Relict piling and rubble from oyster industry.

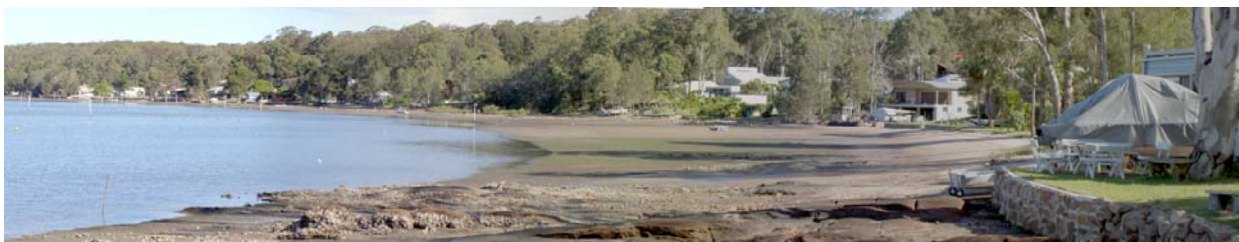
(1) Foreshore reclamation and grouted vertical masonry sea wall – north end.

Figure 2.12. North-west coast of North Arm Cove

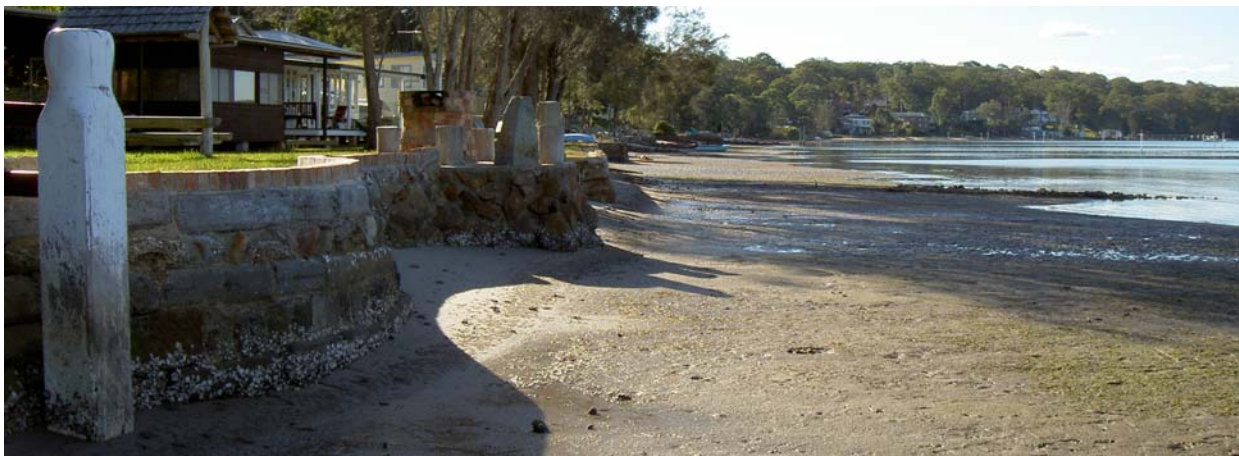
(2) Foreshore reclamation and grouted vertical masonry sea wall – south end.

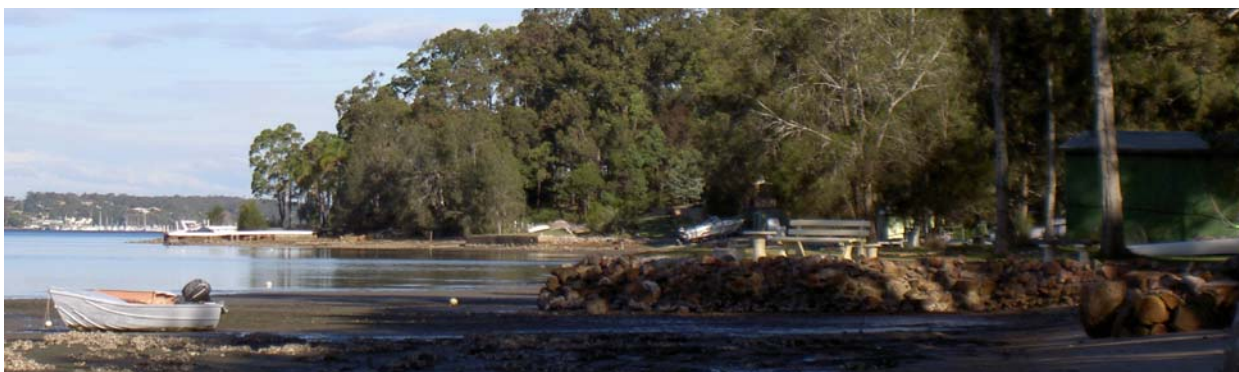
(4) Typical reclamation with rock rubble protection – south end.

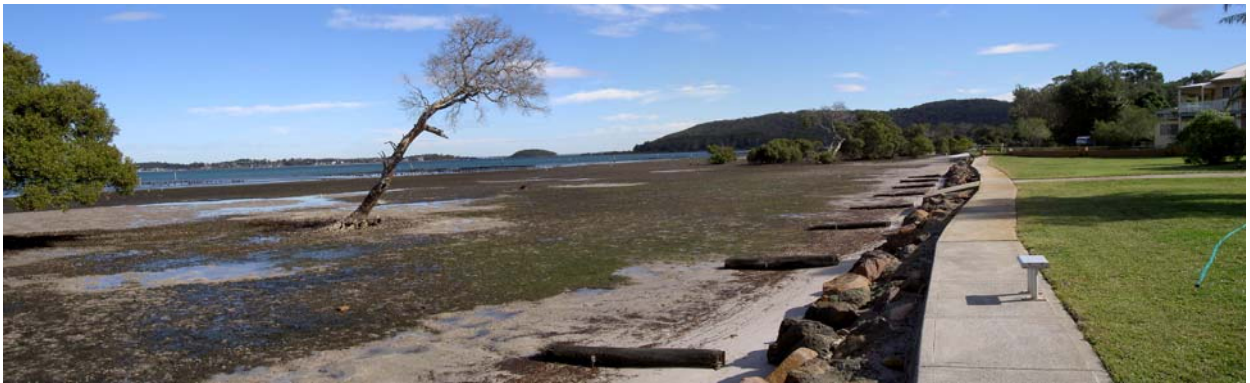
(3) Foreshore reclamation, masonry sea wall and log groynes.

Figure 2.13. Lower Pindimar
