Living on the Edge

The Port Stephens Foreshore Reference Document Attachment 1 to Port Stephens Foreshore Management Plan

AUGUST 2009

Port Stephens Foreshore Plan of Management – Ecology Reference Document

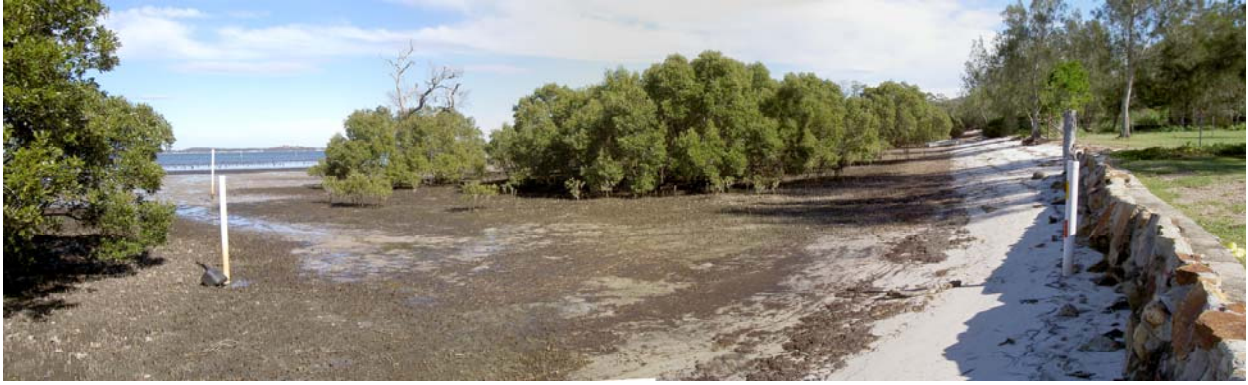
(1) Foreshore protection at boat access way through mangroves.

Figure 2.14. Orungall Point

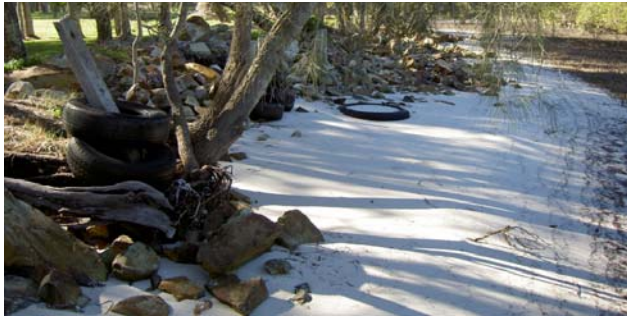
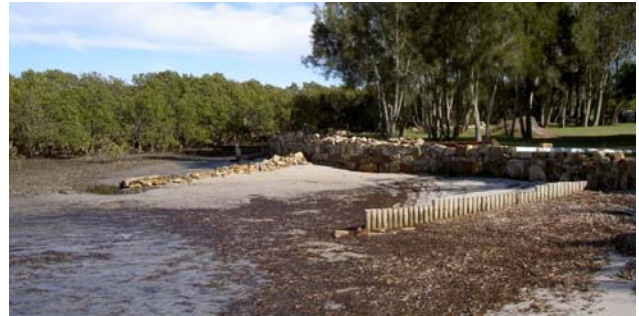
(2) Strewn rock rubble, tyre, rock and pole groyne foreshore protection structures.

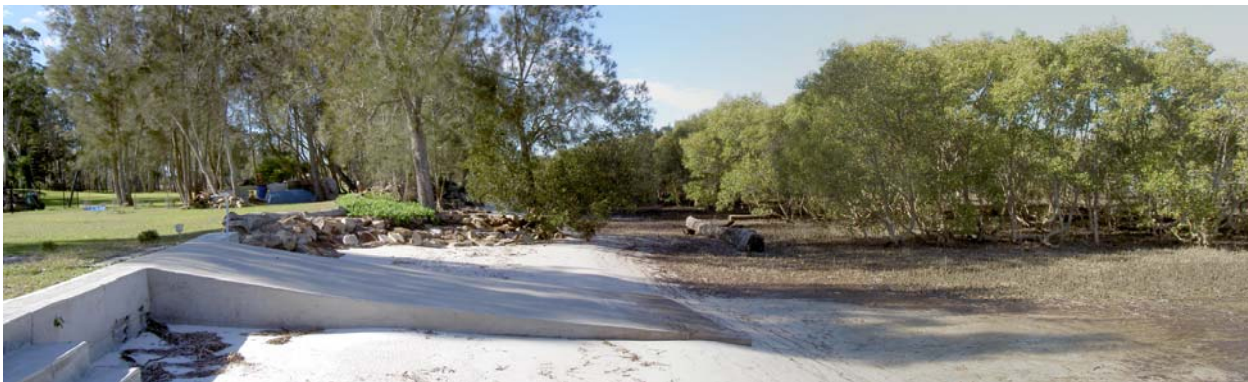
(3) Foreshore reclamation and boat ramp access flanked by rubble protection.

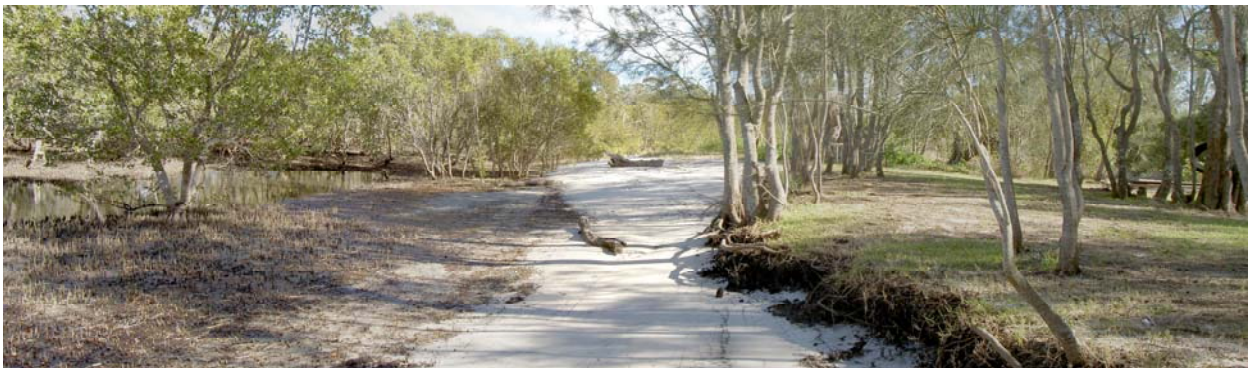
(4) Natural foreshore with beach accretion behind protective mangrove stands.

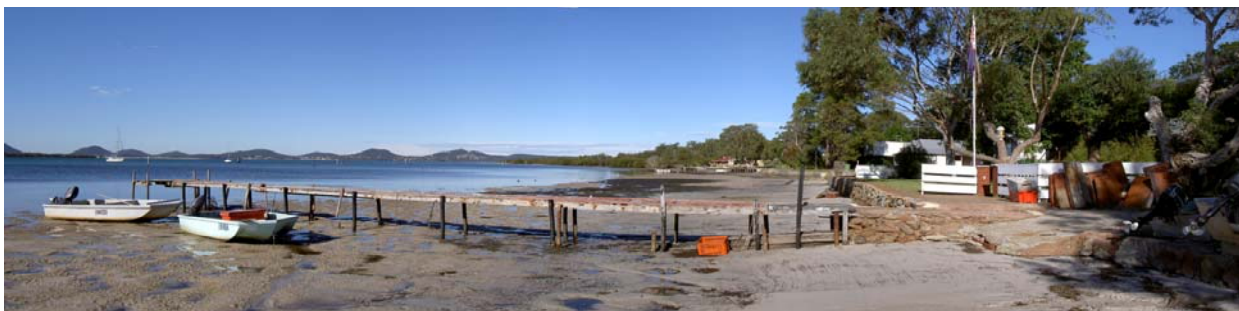
(1) Foreshore reclamation, sea wall protection and Jetty.

Figure 2.15. Pindimar

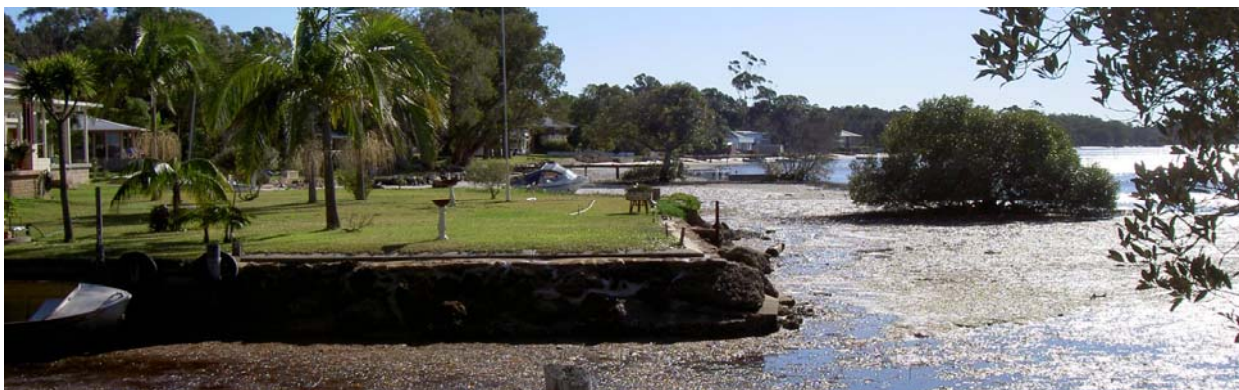
(2) Foreshore reclamation and seawall protection.

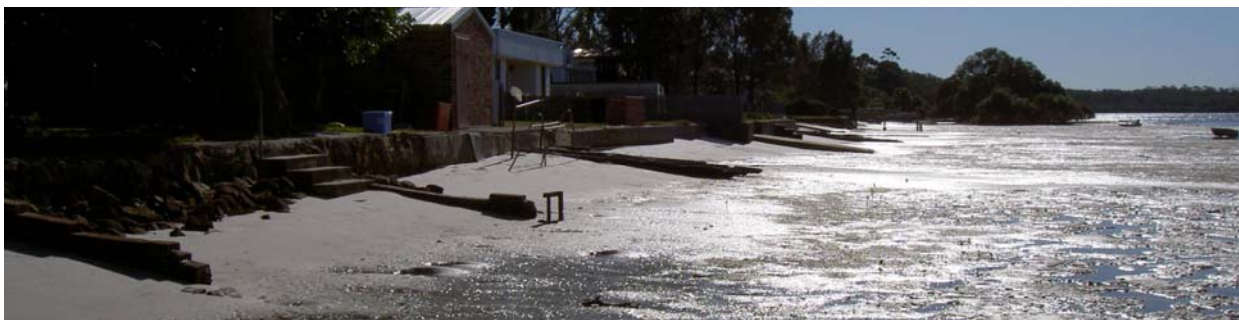
(3) Foreshore reclamation, seawall and groyne protection.

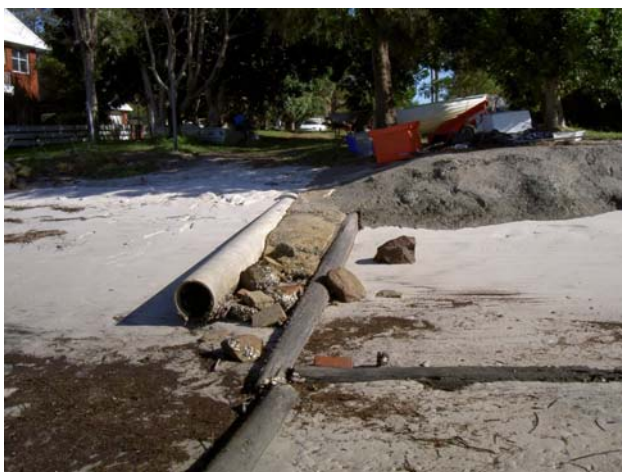
(4) Stormwater drainage across reserve.

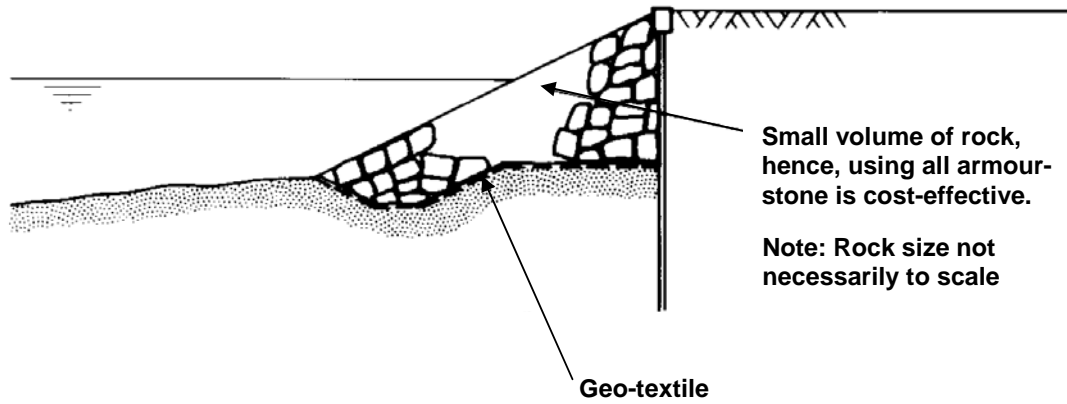
Figure 3.1. Rehabilitation schema for small vertical revetment.
(after CIRIA, 1991)

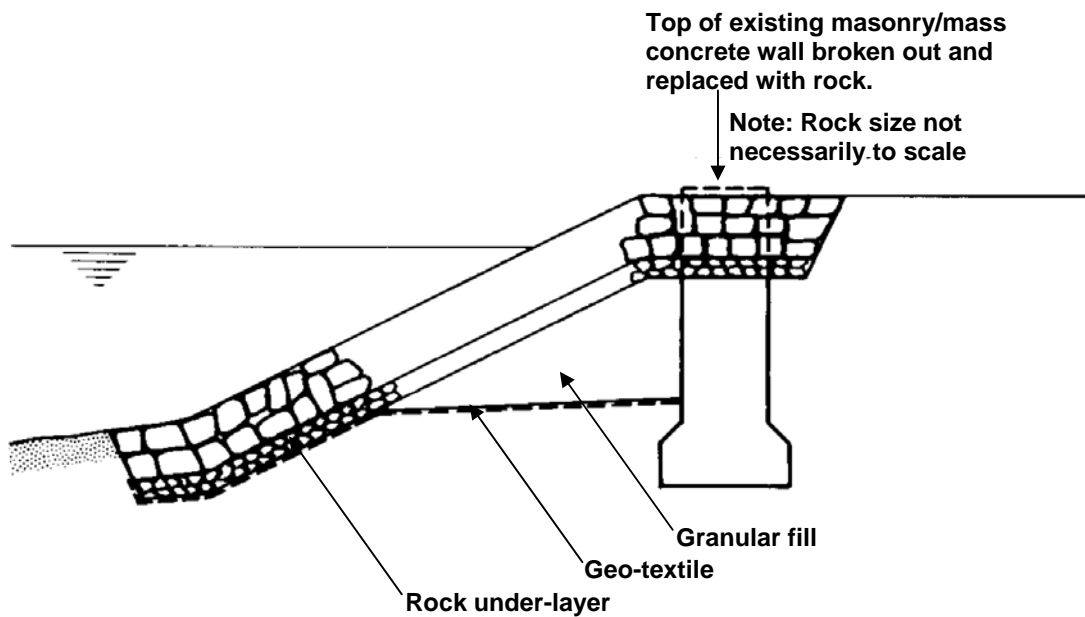
Figure 3.2. Rehabilitation schema for a vertical masonry revetment needing some breaking out.
(after CIRIA, 1991)

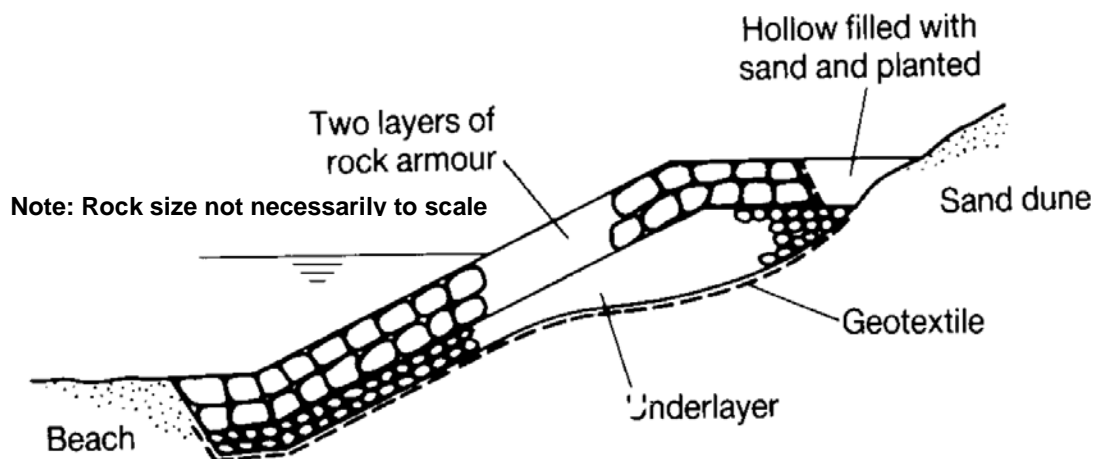
Figure 3.3. Revetment schema on a natural foreshore.
(after CIRIA, 1991)

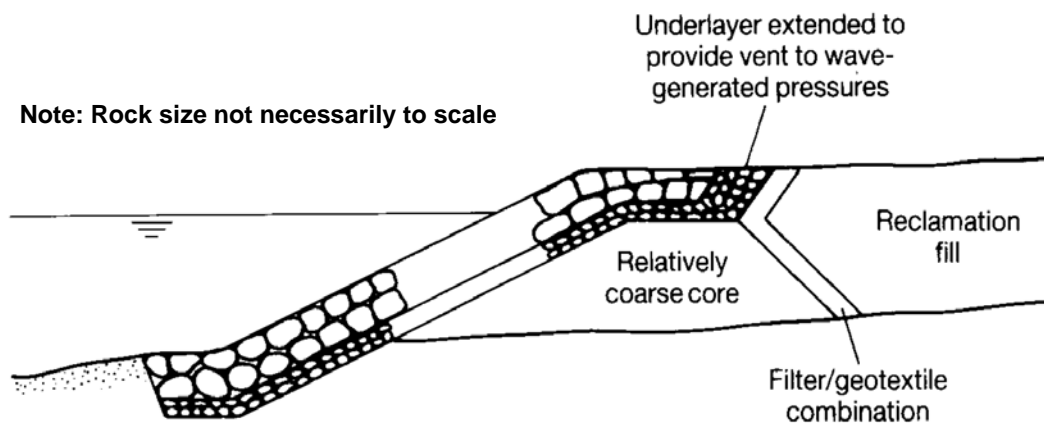
Figure 3.4. Revetment schema to suit reclamation.
(after CIRIA, 1991)
